NASSCO REPORT: GROUTING COMMITTEE

CONTRACTOR, MUNICIPALITY, MANUFACTURER Work Together Solve A Unique Problem In Norwich, Connecticut

BY JOHN P. MANIJAK

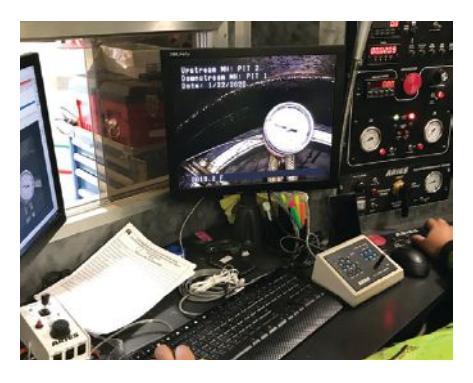
Air testing and Sealing Mainline

Logiball, Inc. custom-built an extended 14-in. flexible packer specifically for this job. The use of a special soft rubber skin allowed the packer to seat against the deformed pipe walls with a 60-in. long void span in between the expanded ends. Three ports to permit pressurization were set within the void area. This allowed the crew to conduct air testing and sealing of the pipe using AV-100 acrylamide grout.

Sealing at just one or two points in the pipe section would not prevent water migration. The decision to test and seal the entire length of pipe from pit one to pit two was made based on the ability of ground water to travel throughout the full length of the pipe section in the pipe trench. Approximately 150 air pressure tests were performed in the 750-ft section of pipe. Upon failure of the air test, AV-100 acrylamide grout was pumped through the open segment of pipe to the exterior of the pipe. After the chemical gelled, a second air test was performed to assure the pipe was sealed. After the grouting of the mainline section was completed, the fourth and final segment of the CIPP pressure liners was installed, cured and tested. The newly CIPP-lined force main was then handed back over to NPUs.
