**TECH
TIPS**

STRUCTURAL REHABILITATION OF MANHOLES

By NASSCO Manhole Committee Member V. Firat Sever, PhD, PE, QuakeWrap, Inc.

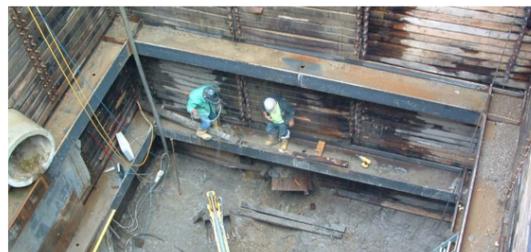
Replacement efforts after a deep, collapsed manhole.
