# **METHODS TO CONTROL LEAKS IN SEWER COLLECTION SYSTEMS**

**White Paper**

**C. Vipulanandan, Ph.D., P.E.  
and  
H. Gurkan Ozgurel**

**October, 2004**

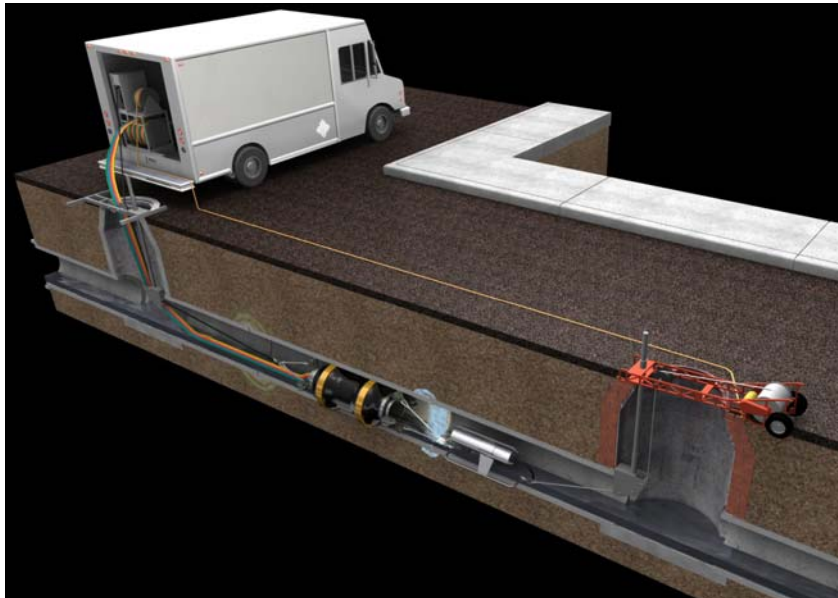
**Figure 6. Typical Grout Application Setup**

The intent of grouting is to seal sewer pipe joints which fail to pass joint tests or have leakage rates of ¼ gallon per minute or more. The basic equipment consists of a closed-circuit television system and the necessary chemical sealant containers, pumps, regulators, valves, hoses and joint sealing packers for the various sizes of sewer pipes. A cylindrical packer is used to seal small and medium sewer pipes from 6 inches to 42 inches in diameter [ASTM F 2304, 2003]. Larger diameter pipes may be grouted with specialized packers or man entry methods. See Figure 6.
