The Test Cell Grouting Research White Paper

NASSCO

Version: 1.0
May 2023

Introduction: In 2016, a group of engineers, contractors and vendors began working on an update to the NASSCO packer injection grouting technical specifications. It was recognized that recent practices in chemical grouting, called Capital Grouting had achieved significant long-term reductions in infiltration. These results were documented via independently conducted studies. The changes in tools, practices and procedures were based on an understanding of how the grout in situ was achieving long-term seals. These results were backed up by several studies conducted using pre and post rehabilitation control-based procedures to determine that not only was long term infiltration elimination effective but remained effective for over a decade. The group's objective was to update the NASSCO packer injection grouting technical specifications to incorporate the Capital Grouting techniques and to differentiate them from the traditional, short term or pre-rehabilitation grouting methodologies. While developing these specifications several questions arose that necessitated scientific investigations. To confirm/prove the

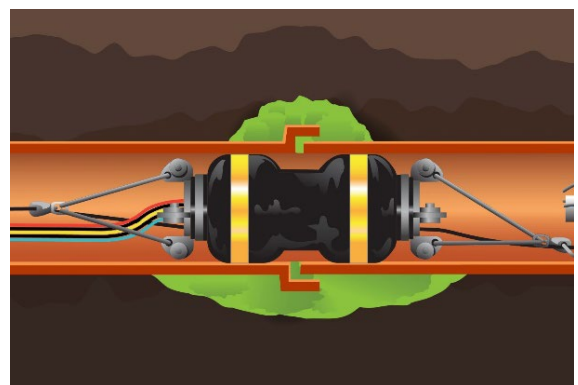
Figure 3: Mainline Packer Grouting Joint

This was done by assessing the impact of the grouting variables to assess where the grout was placed to provide the best long-term results in sealing the actual defect, stabilizing the pipe, and providing a trench dam to reduce trench water migration.

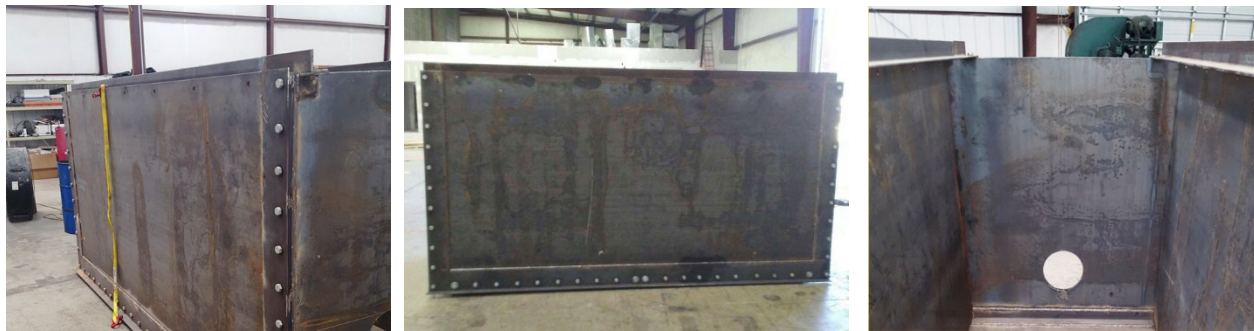
Figure 4: Test Cell During Construction

The full-size Test Cell was constructed of steel with bolted panels to allow access for construction and disassembly of the test cell. The dimensions of the Test Cell were ten feet long by six and a half feet high by four feet wide. The Test Cell was also constructed with holes for pipe penetrations through the long ends that allowed a close fit for an eight inch outside diameter vitrified clay pipe. It was also fitted with drain holes at the bottom that would allow for an evaluation of the amount of water that might pass through the test cell structure after it was filled.

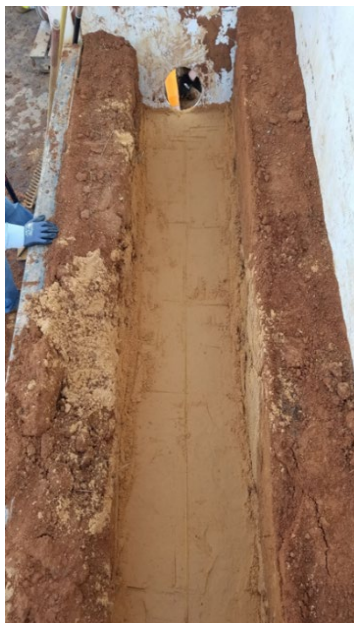
Figure 5: Trench Install

Common and identical construction practices were used throughout all the grouting tests. The test cell was filled about halfway with compacted native North Carolina clean neat red clay. This material was selected because of its low permeability and ability to hold form (i.e., due to cohesion) allowing a trench to be excavated with vertical sides reducing the overall Test Cell width. The clay was placed moist and compacted in eight-inch lifts, to a depth of two and a half

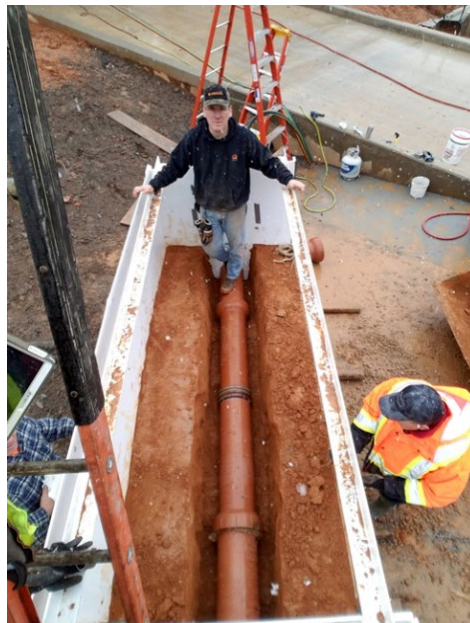
Figure 6: Pipe Install with Defects

Once the trench was excavated, the selected pipe bedding was placed as a four-inch lift inside the trench. The bell holes were cleared for the two segments of pipe that were placed in the middle of the trench, with the female ends facing out and the male ends of the pipes butted together and filled with oakum. This male-male mimicked a circumferential fracture / fully open joint (Figure 10) – commonly found in many pipes. This was labeled Joint “B” – or Defect “B”. Two additional pipes were then inserted through the holes at the ends of each side of the box with the spigot end first and then pushed into the outward facing female bell ends.¹

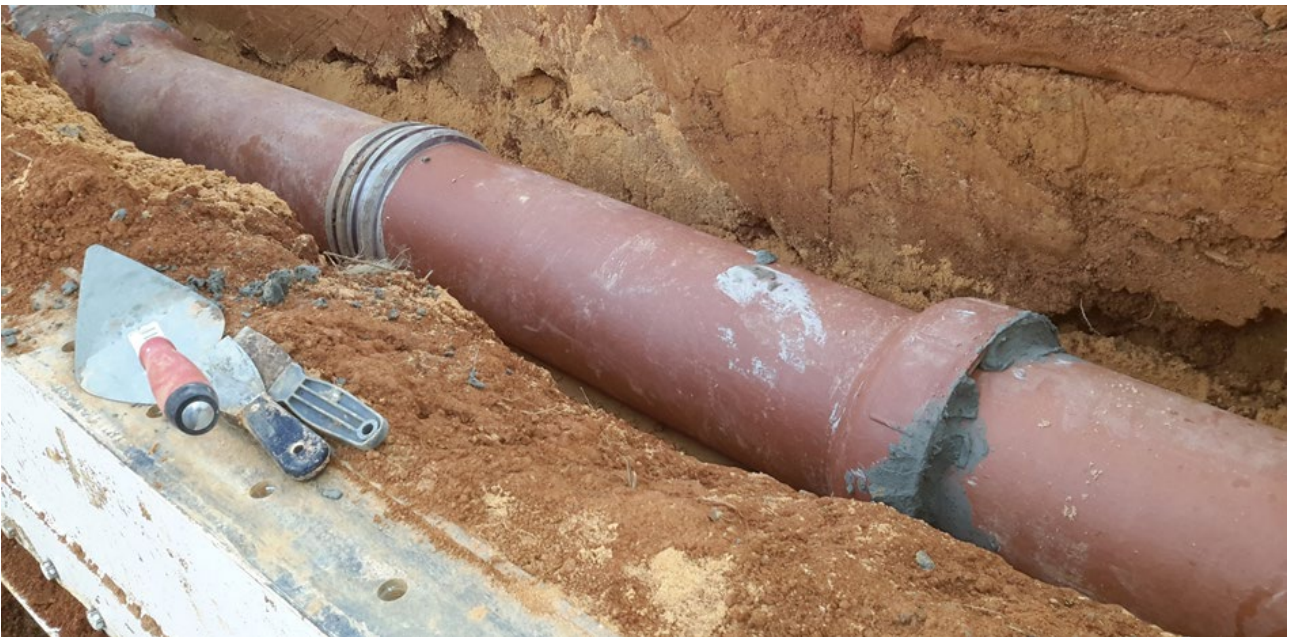
Figure 8: Pipe Defects Recreated Prior To Backfill

The two additional pipes were then connected to the female ends of the middle pipe and sealed with a hydraulic cement. A single point was left open recreating a joint defect in each of them. The openings or defects were the size of a screwdriver width – less than one square inch opening.

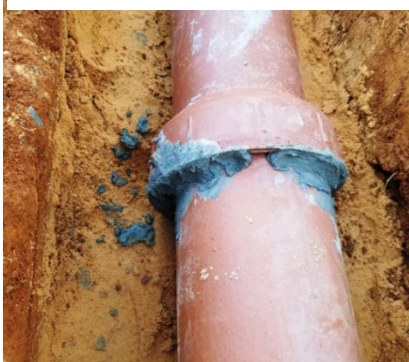
Figure 9: Defect C - 12 o'clock Position

For Joint “A” – the Defect “A” was placed at the 3 o’clock or spring line position and for Joint “C” – the Defect “C” was placed at the 12 o’clock position (Figure 9).

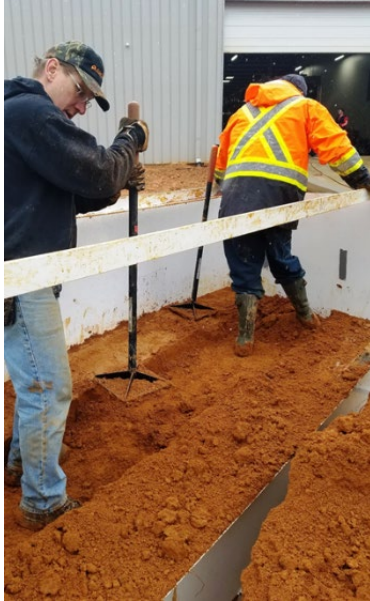
Figure 12: Hand Tamping

The remainder of the pipe bedding was then placed around the pipe to the spring line. It was tamped in by foot, not shove sliced. This was to mimic conditions that are commonly seen in past clay pipe installations. The pipe was then photographed as it was bedded to the spring line. After that additional bedding material was added in two more loose lifts about six inches each, and then hand tamped until six inches of material was placed above the crown of the pipe. At that point, the alignment was checked from the outside of the test cell making sure nothing had been disturbed or broken. The entire bedding was then saturated until water was observed entering the pipe defects. Any water that remained in the trench was meant to remain, mimicking the movement of rainwater or ground water along utility and sewer trenches⁽²⁾.

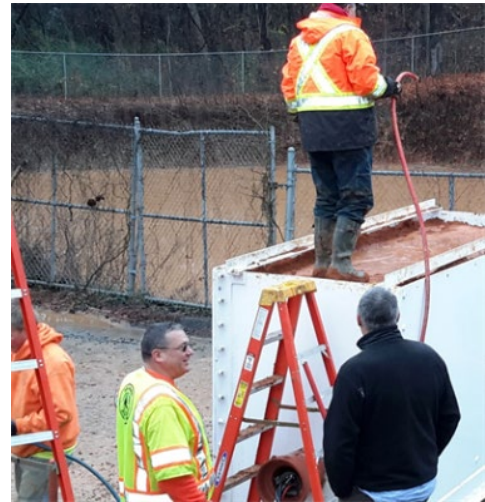
Figure 13: Saturating Full Installation

test cell filled completely, the entire surface of the test cell was saturated with water. After 20 minutes, the surface was tamped again. Upon completion of this step, a full four and a half feet of backfill material had been placed over the pipe. This practice was modified for the second half of the tests; instead of filling the test cell to the top with clay, only two and a half feet of clay was placed on top of the pipe bed (for soil cover) then plywood plates with sand

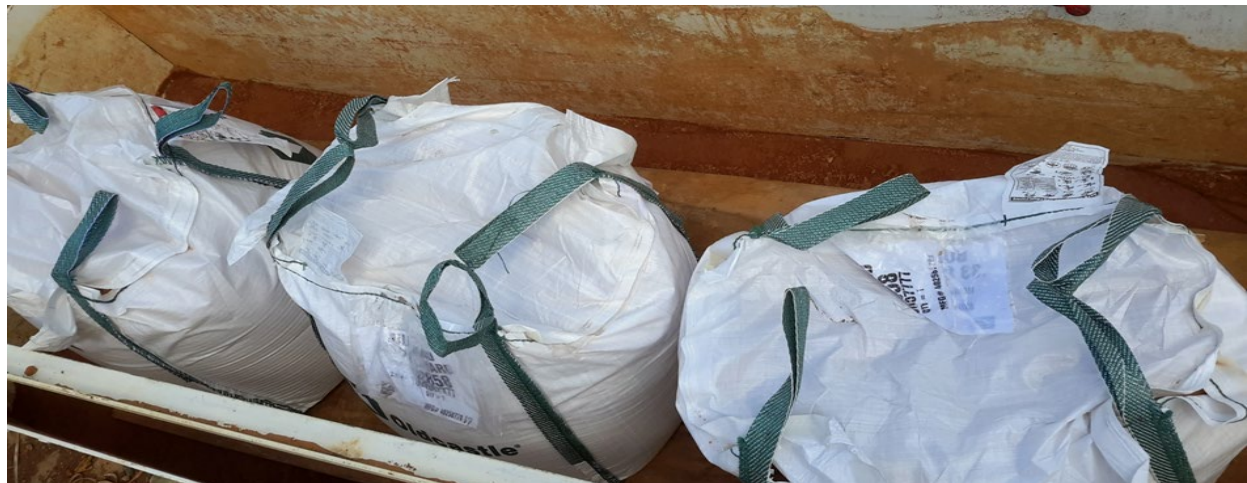
Figure 14: Super Sacks Used to Recreate Typical Soil Loading

filled super-sacks were placed on top. This method was quicker to install and disassemble while still recreating typical soil loads on top of the pipe (Figure 14).

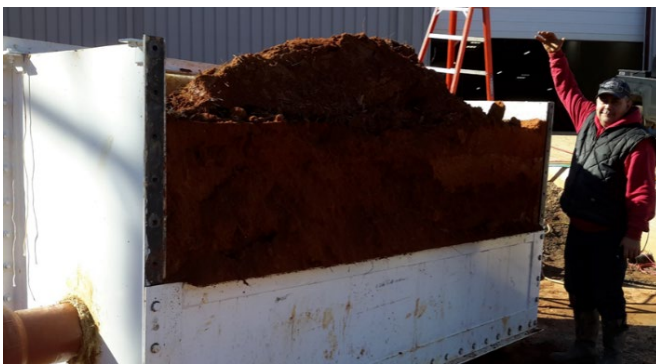
Figure 16: Superior Plate of Test Cell Removed After Grouting

It was observed that in some instances more than three and a half gallons of grout was pumped into joint “C”. The defects were injected in one-gallon increments. This was to determine if there was a difference in the way the grout was delivered after the initial injection, either pumping to the maximum allotted amount or until refusal, meaning that the joint was sealed.

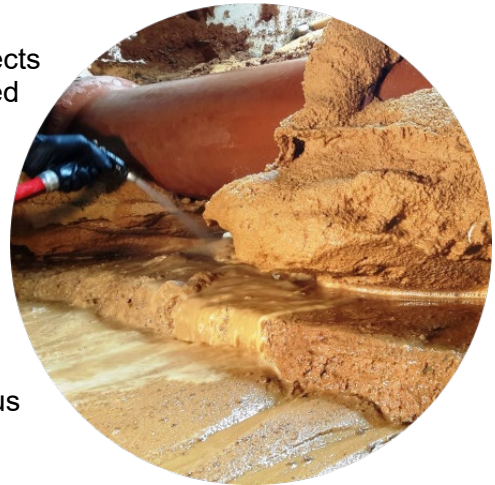
Figure 18: Water Used to Remove Loose Material

After the general grout outline around each of the three defects was determined and photographed, a garden hose was used with low water pressure to wash away any loose materials. This revealed what had been grouted or not each step of the way. After documenting the grout shapes and masses, each grout matrix was then dissected to determine the internal forms.

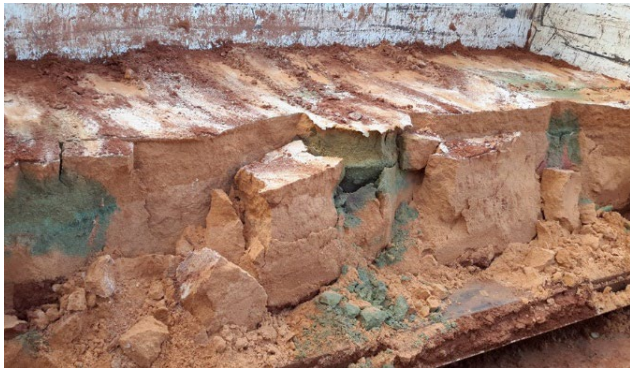
Figure 20: Colored Grouted Formation First Revealed

Tests 1 and 2 were completed in sand bedding, using a three-gallon per minute (gpm) pumping rate and 20-second and 55-second gel times respectively. The different colored grouts were pumped in sequential increments using red, then blue, and then yellow dye.

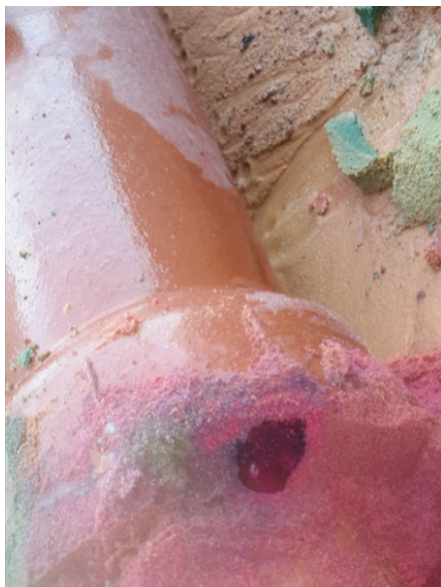
Figure 23: Neat Grout Located Outside Defect A

At Defect A located at the 3 o'clock position, the red grout, which was the first grout pumped, traveled the furthest from the defect. Because the gel time was at 20 seconds, the red grout

composed most of the actual pipe defect sealing material. At the actual location of 3 o'clock defect the seal was primarily red grout with very little soil mixture (Figure 23). The second stage of blue grout broke out through the original neat red grout plug (Figures 24, 25, 26) and moved toward the top of the pipe as a separate mass. (Grout on top of the pipe is of very limited value for pipe stabilization.)

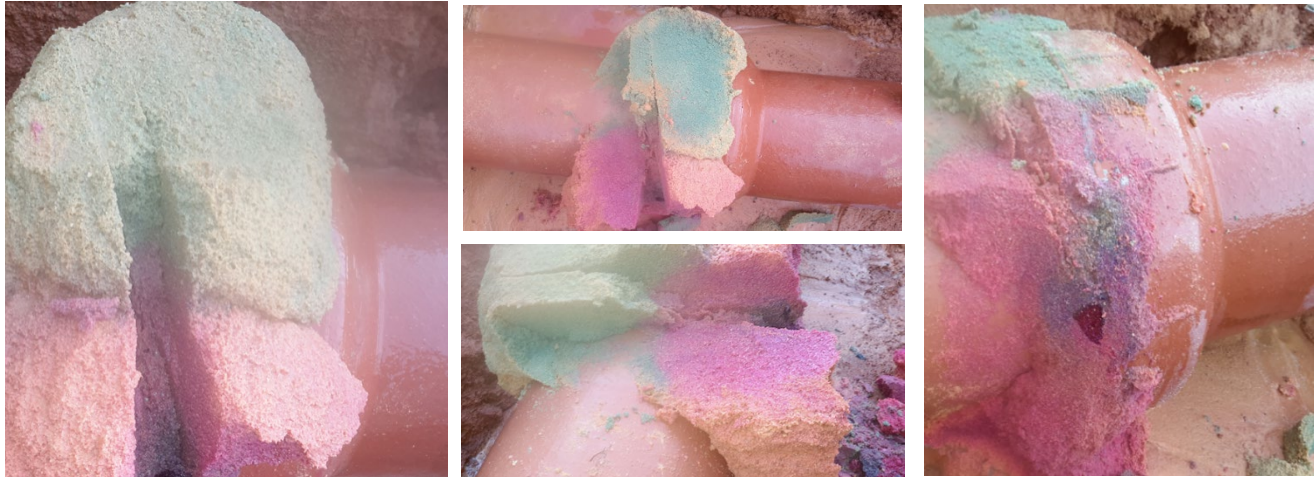
Figures 27, 28, 29, 30: Dissection of Defect A Grout Mass

The blue grout broke through the red grout and followed a separate path, creating its own mass. This is theorized as a function of step grouting since this formation may not have occurred if the initial red grout was continuously pumped to refusal.

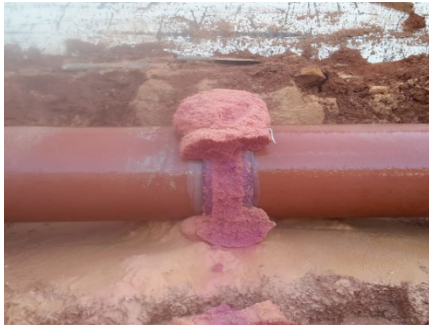
Figure 32: Defect B Grout Formation

The grout formation that was located around the circumferential fracture at Defect B appeared to have fully encompassed the structure.

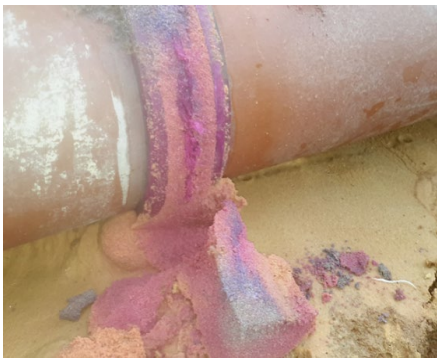
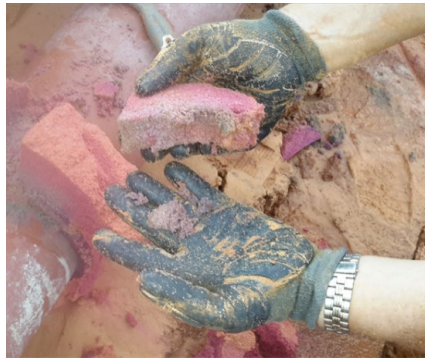
While this defect was a full circumferential fracture, only 1.25 gallons of red grout and 0.15 gallons of blue grout were able to be pumped before blow-by of the packer (void space over pressurization) occurred. When dissected, all the grout formations close to the pipe were red in color, and blue grout was again on top of the pipe, with very little grout supporting the underside of the pipe.

Figure 35: Defect B Dissection

Figure 36: Defect B Dissection

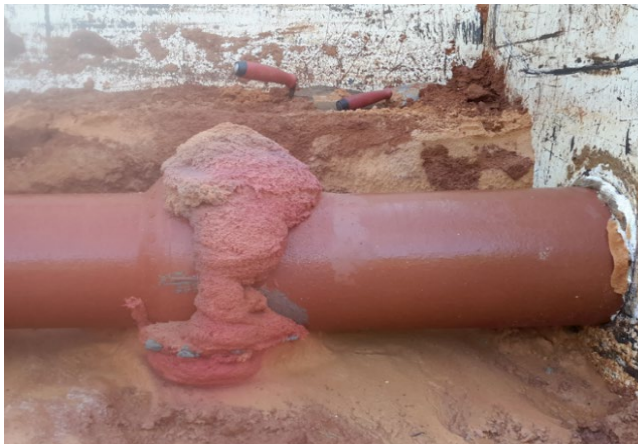
Figure 38: Defect C Seal Side View

At Defect C located at the 12 o'clock position, 1.55 gallons of red grout were pumped first, then only 0.35 gallons of blue grout were pumped before refusal was achieved. The grout came out

of the top of the pipe as expected based on the defect orientation. Most of the grout resided just outside of the defect with minimal grout travel around the sides of the pipe and settling at the bottom or invert of the pipe. The fast gel time limited the ability of the liquid grout to migrate below the pipe providing very little pipe stabilization.

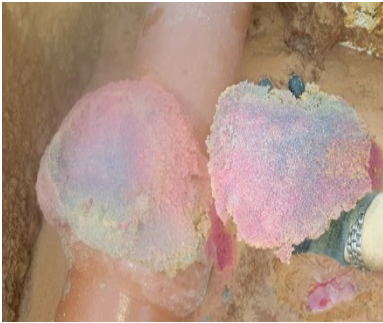
Figure 40: Defect C Dissection

When the mass was dissected, the interior of the seal was primarily the initial red grout around the defect. The small amount of blue grout pumped remained close to the pipe joint defect.

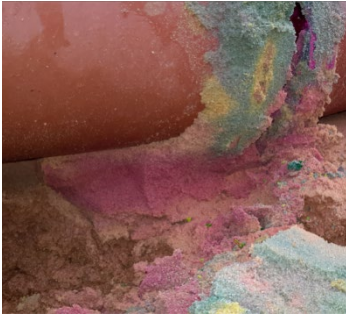
Figure 43: Red Grout Observed Below Pipe

Dissection of the grout confirmed that the red grout immediately migrated below the pipe (Figure 43), providing the cradling of the invert. The blue grout pumped second - filled the areas near the pipe joint defect. Finally, the yellow grout – pumped last, fracked through the blue mass, turned green, and established a mass above the pipe (Figure 45).

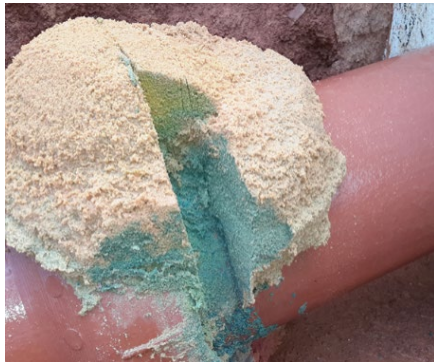
Figure 46: Dissection of Defect C

Defect C was located at the 12 o'clock position. With a 55 second gel time, the red grout migrated below the pipe.

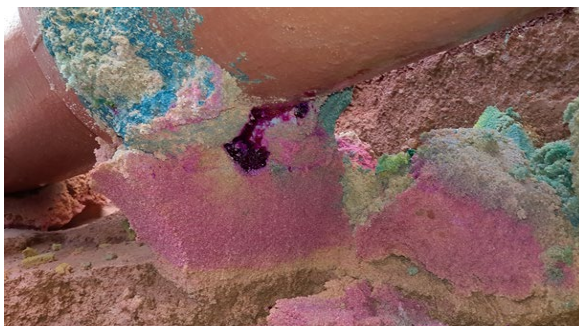
Figure 49: Neat Red Grout Observed Below Pipe

The grouted mass was filled with a combination of red and blue grout. The lower gel/soil matrix was primarily red with the blue completing the upper portion of the mass (Figures 49 & 50).

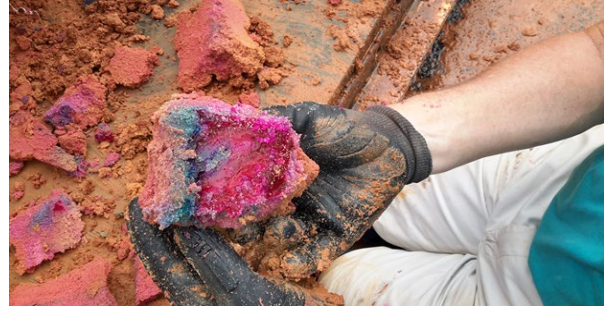
Figure 52: Dissection of Lower Portion

portions of the mass. No yellow grout was observed in the red grout. The third grouting increment formed outside the first two colored masses. The mass around the defect was primarily blue with an absence of red. The longer gel time allowed for the first pumped red grout to migrate below the pipe.

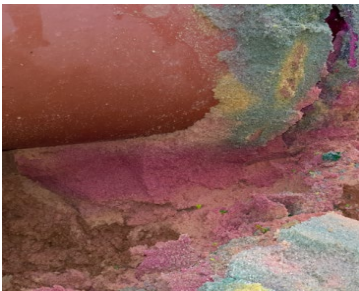
Figure 55: Grouted Mass Below Pipe

A side-by-side comparison of the dissection of the gel/soil matrices revealed the effect of the gel time on the grout movement, the pipe cradle support, and the final seal. The gel mass that was observed with the shorter gel times sealed the defect earlier (with less grout) but did not provide cradle support. The longer gel time allowed for the creation of the pipe cradle support with the initial grout pumped, whereas the second and third grout injections sealed the defect.

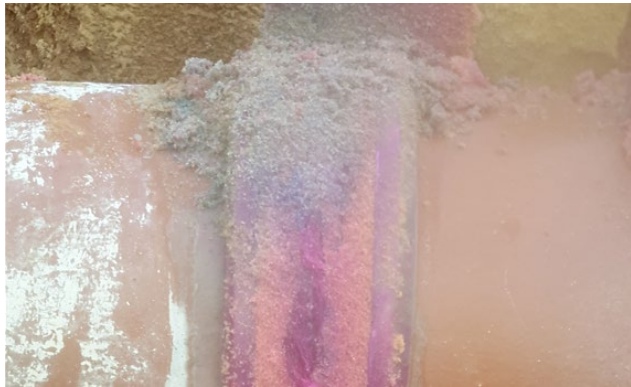
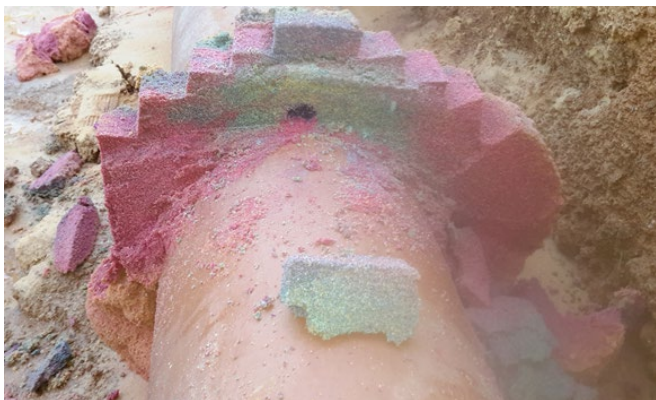
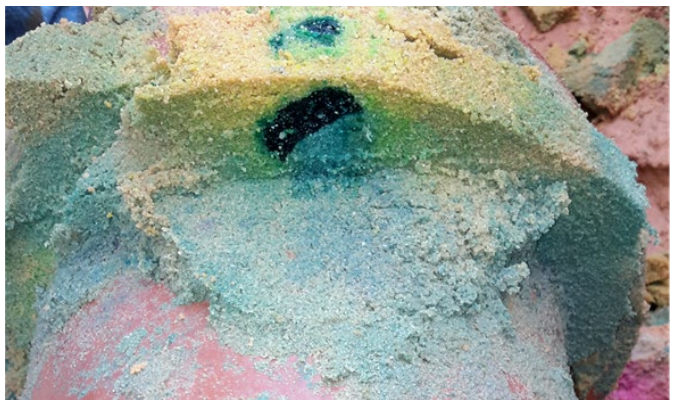
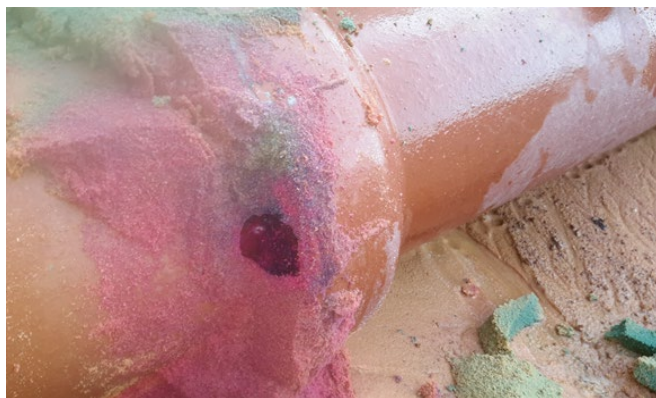
Figure 57: Side by Side Comparison between 20 seconds and 55 gel times.

20 Second Gel Time

55 Second Gel Time

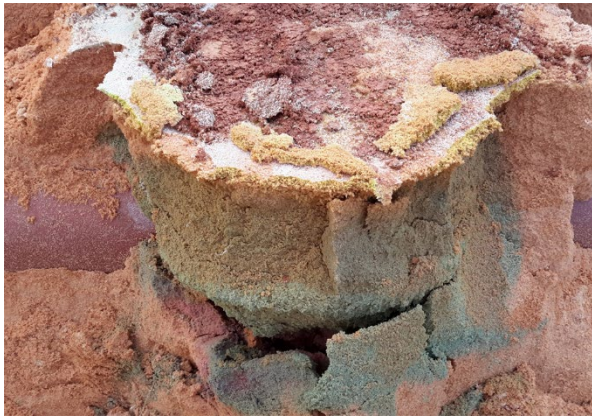
Figure 58: Upward Grouted Mass Above Defect

Once grout begins to set up within the bedding, any subsequent grouting steps tend to create an upward directional mass rather than allowing the grout to migrate below the pipe and saturate the bedding.

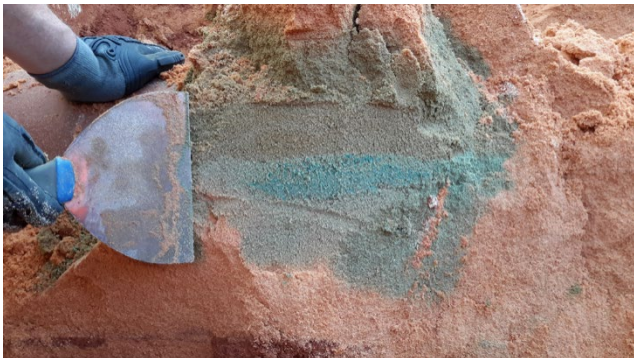
Figure 60: Colored Grout Layers

The grout materials used in the colored grout injection tests did not contain any latex or other additives. This was to allow for the observation of the different grout injections using colored dyes. The following tests utilized grout formulas containing 1.5% latex (by total batch volume). The resulting grout matrices which included latex exhibited increased stiffness, compressive strength, and flexibility.

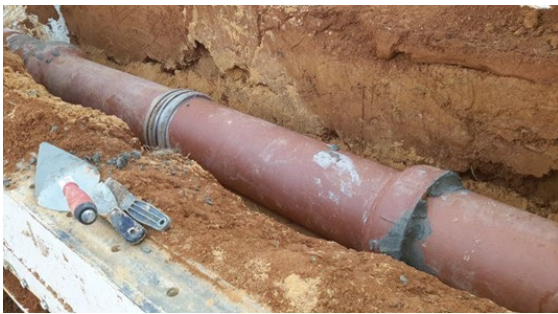
Figure 63: Pipe Installation Prior to Backfill

Following the test cell construction procedures described earlier, the trench was constructed of native North Carolina neat red clay. The pipes were then bedded in clean sand in four-inch lifts and then hand tamped until six inches of sand backfill was placed over the crown of the pipe. Two and a half feet of material was placed on top of the pipe and then plywood plates with sand filled super-sacks were placed on top.

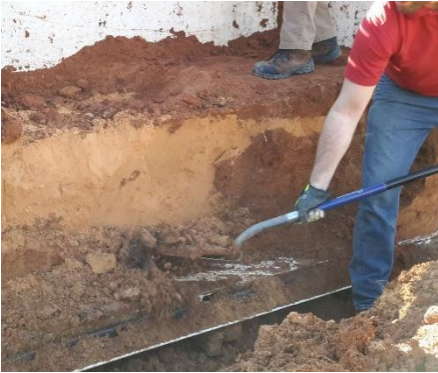
Figure 64: Removal of Loose Backfill After Grouting

Once a seal was achieved, the overburden was removed and each of the grout masses were meticulously exhumed using small hand tools and light water washing.

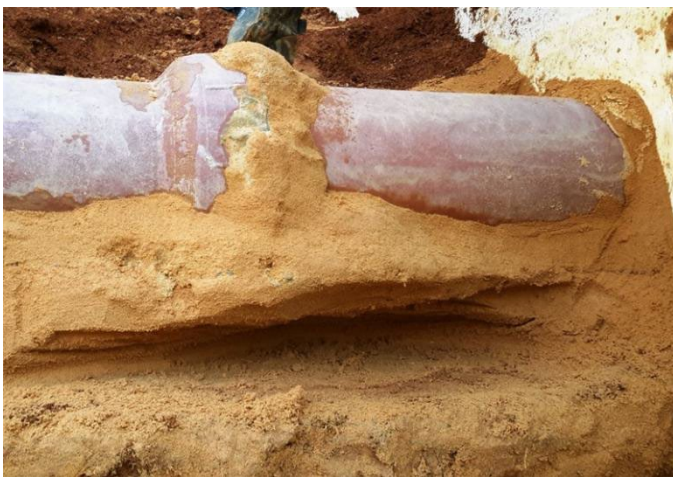
Figure 68: Grout Migration Below Pipe

Upon general excavation the grout mass that formed at the defect located at the 12 o'clock position migrated below the pipe providing the cradle support of the invert and surrounded the pipe.

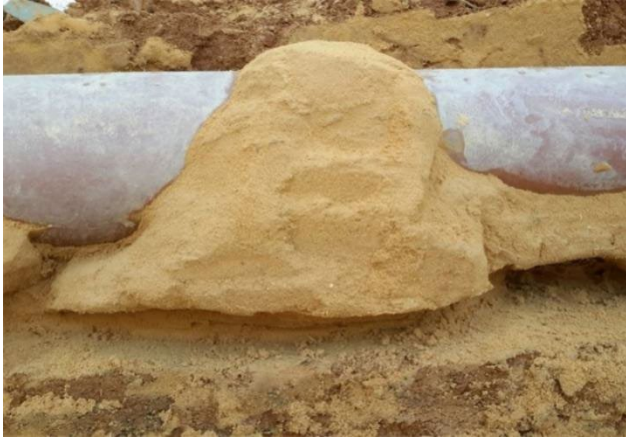
Figure 70: Side View Grouted Defect

Upon general excavation it was observed that the grout mass that formed at the circumferential fracture defect migrated below the pipe providing the cradle support of the invert and surrounded the pipe.

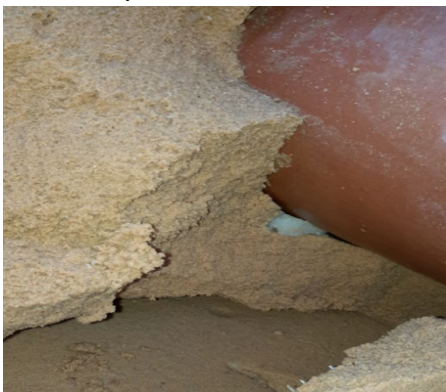
Figure 73: Neat Grout Below Pipe

The first observation was that **the grout initially descended downward and filled any bedding void under the pipe**. There was no mixing of sand and grout because there was no sand in that void space area. The settlement voids in the outside invert and haunch areas are typical of many

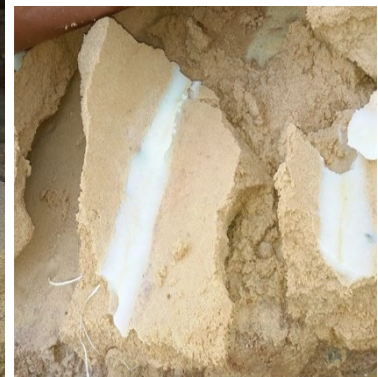
Figure 75: Voided Area Below Pipe

in-situ sewer pipe installations, especially those where leakage into the pipe over long periods has led to migration of pipe bedding material.

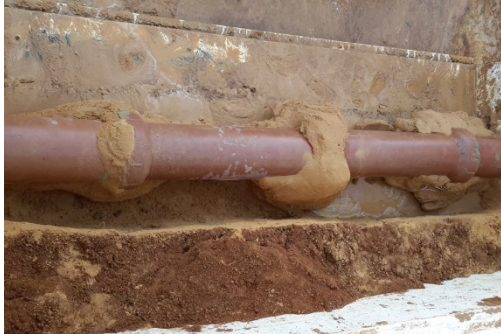
Figure 76: Top / Plan View of Grouted Defects

After the grout filled the void space (pathway of least resistance), it began to saturate the pipe bedding material. During this time, grout continued to move longitudinally, circumferentially, and laterally (but not upward). Longitudinally, the grout almost connected to the next grout mass traveling approximately one and a half feet in both directions along the pipe. Laterally, we observed **the grout migrated out to the edges of the pipe trench, stopping where it encountered the compacted clay (which served as the surrogate for undisturbed native soils).**

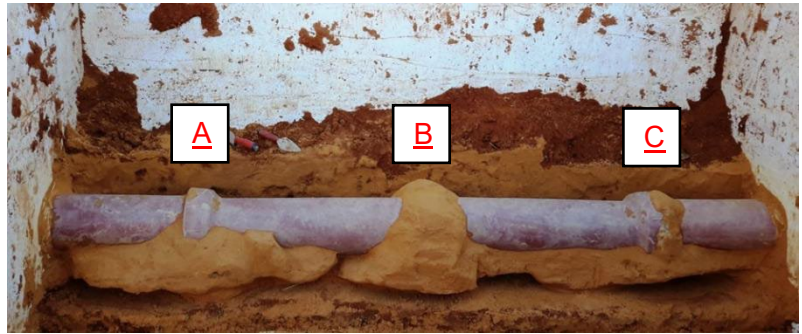
Figure 77: Side View of Grouted Defects A, B, & C

After the grout solidified below the pipe, it began to build up around the pipe creating a seal that encased the defect. At Defects B and C, the grout surrounded the entire pipe circumference. At Defect A, the grout extended above the 3 o'clock position.

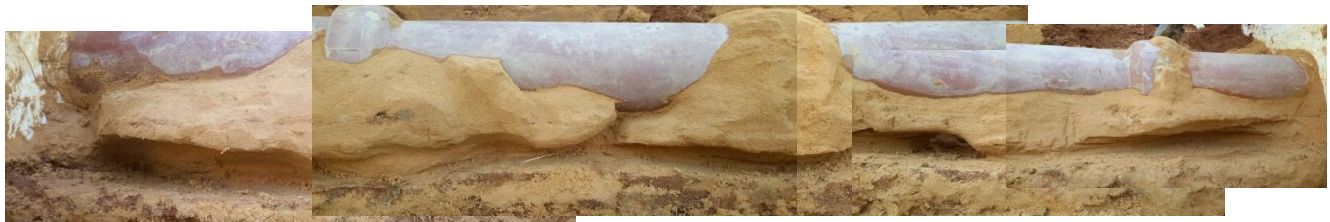
Figure 78: Close-Up of Lower Portion of Defect Seals and Pipe Stabilization

The grout was able to penetrate the bedding material filling all voids and reaching the impermeable clay sub-base for Defects A, B, and C. This resulted in significant longitudinal pipe cradle support and damming of water in the trench.

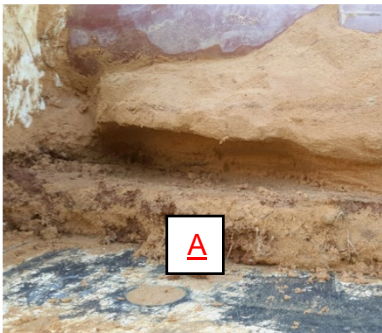
Figure 80: Grouted Formation at Defect A

When using a 55 second gel time, we achieved a significant volume of gel/soil matrix below Defects A, B, and C, and around Defects B and C.

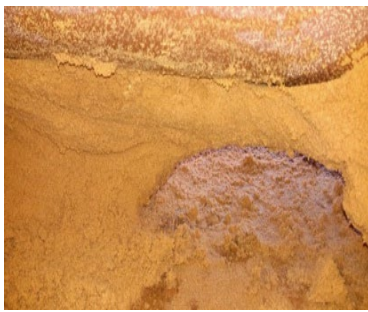
Figure 83: Bridge Between Formations

Grout permeation of the soil was observed leading to improved pipe support along the pipe. A thin layer of neat grout was observed between adjacent defects that ran along the bottom of the pipe in the void area.

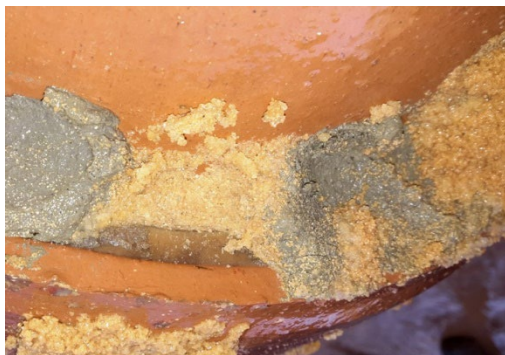
Figure 86: Defect Seal

The defect itself is sealed with neat grout immediately inside and around the defect while filling the potential void space/gaps outside the pipe. The neat grout then permeated the surrounding soil, filled the interparticle void space and created a gel/soil matrix. This provided the additional pipe support and an impervious seal.

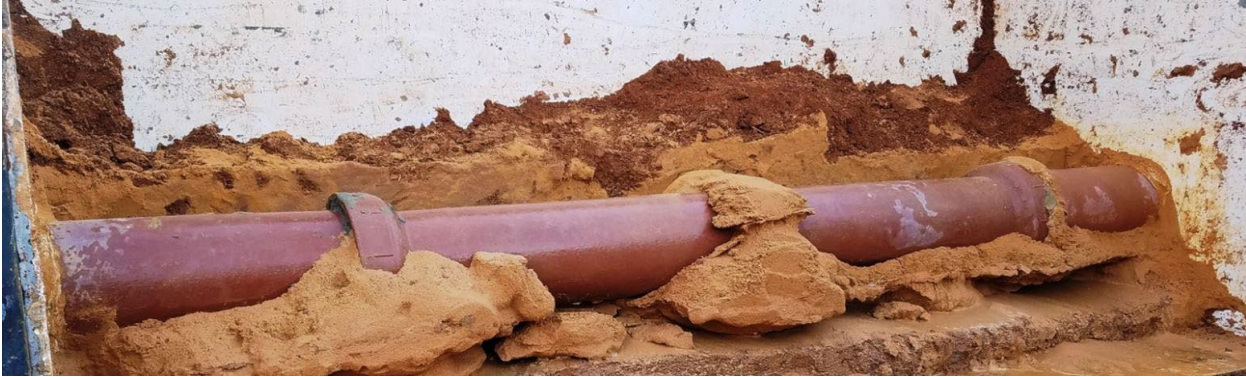
Figure 88: 55 Second Gel Time Grouted Soil Formations

- *Descending of the grout immediately below the defect*
- *Saturation of the bedding material extending to the trench base*
- *Connecting of the grout masses longitudinally*
- *Creating a seal around the pipe defect (after pipe stabilization mass achieved)*
- *Permeation of the soil beneath the pipes between the defects*
- *Creating a gel/soil matrix supporting the neat grout defect repairs*

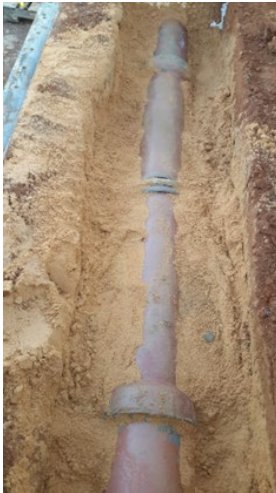
Figure 89: Pipe with Defects Installed

Test 4 was identical to the previous sand test in construction except a 23 second gel time was used.

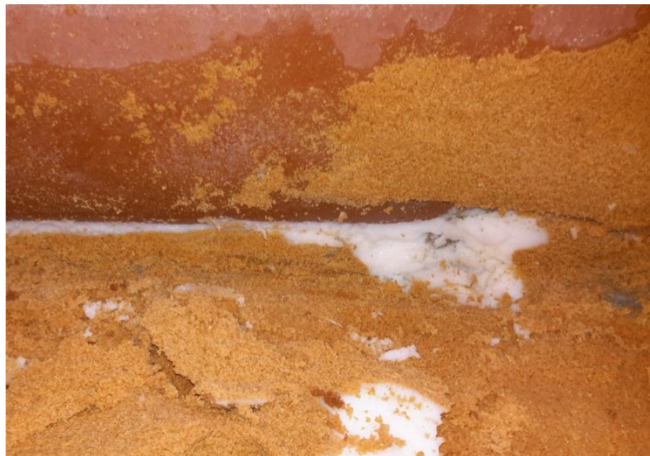
Figure 91: Neat Grout Fills Voids Below Pipe

With the 23 second gel time in sand, there was just enough time for the grout to permeate downward and fill the void area underneath the pipe. However, the volume of grout pumped was less compared to the 55 second gel time (Test 3) due to the shorter gel time, and as expected it did not travel as far as it did in the 55 second test. The grout did not mix with the sand under the pipe or with the haunch.

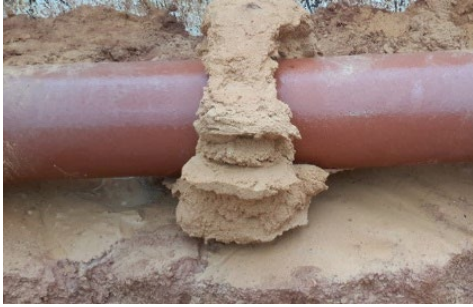
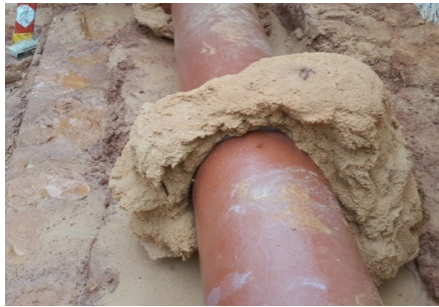
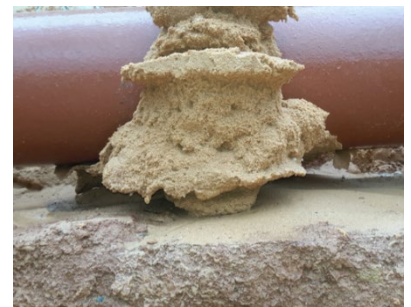
Fracture Defect B (full circumference) – Smaller and more localized “fin-like” grout structures with very limited longitudinal spreading were observed when comparing to the 55 second gel test.

Figure 93: Fin formation front view

Figure 94: Side view of grouted defect

Figure 95: Close-up of fin formations

Upon dissection of the Defect B fins, it was observed that a significant amount of soil fracturing occurred where the grout broke out into neat grout lenses. This was due to the initial pumped grout beginning to gel while continuously pumping fresh grout.

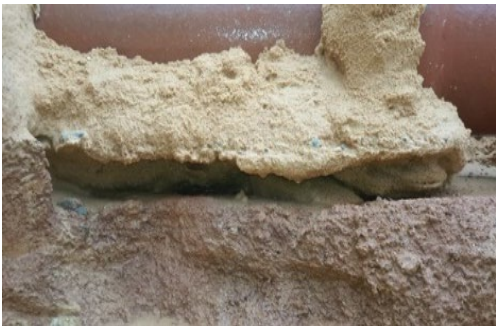
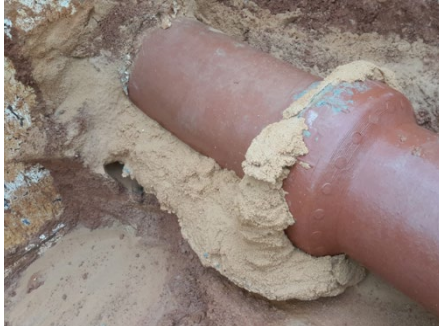
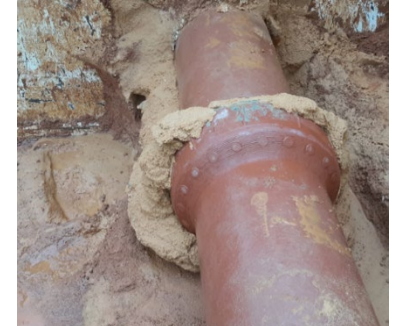
Fracture Defect A (3 o'clock) – Smaller grout structures and reduced longitudinal support was also observed as compared to the 55 second gel test.

Figure 96: Longitudinal Support of Pipe

Figure 97: Sealed Joint with Pipe Support

Figure 98: Grout Matrix observed on opposite side of defect.

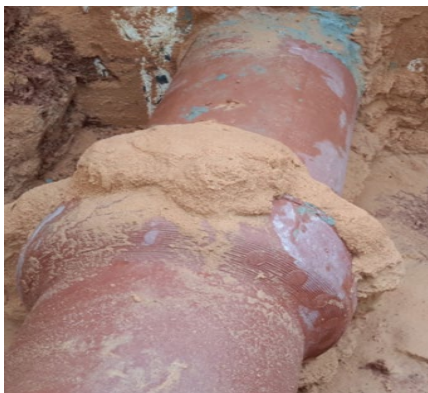
Figure 99: Seal at 12 O'clock Position

Fracture Defect C (12 o'clock) – Smaller grout structures and reduced longitudinal support was observed when compared to the 55 second gel time.

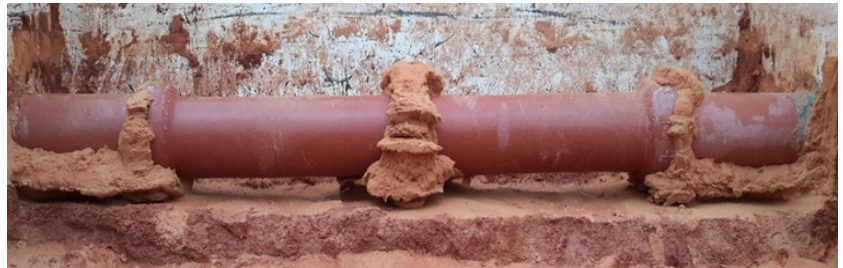
Figure 102: Test Cell Grout Formation Using 23 Second Gel Time

- Neither the 55 second nor the 23 second gel time grouts penetrated the impermeable native North Carolina Clay trench.
- Both grouts filled the void area immediately under the pipe and migrated to the base of the pipe and bedding.
- Both gel formulations sealed the defect or joint with neat grout.

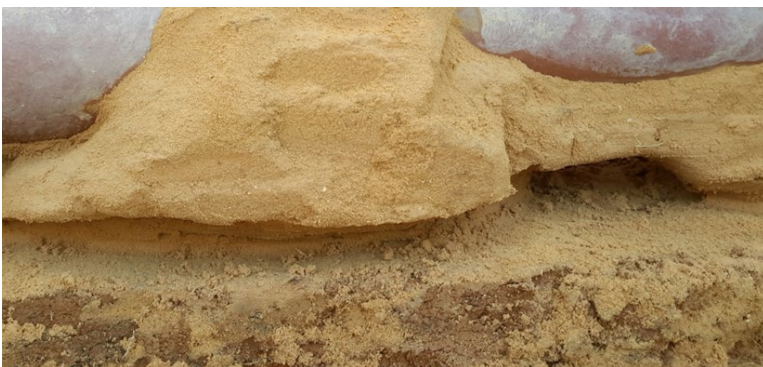
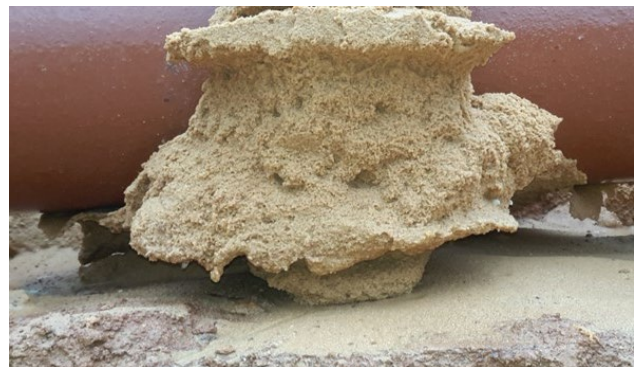
1. **The volume of grout that contacted the sub-base of the trench was much smaller when using a 23 second gel time.** When using a 55 second gel time, the base of the gel/soil matrix was much wider and larger.

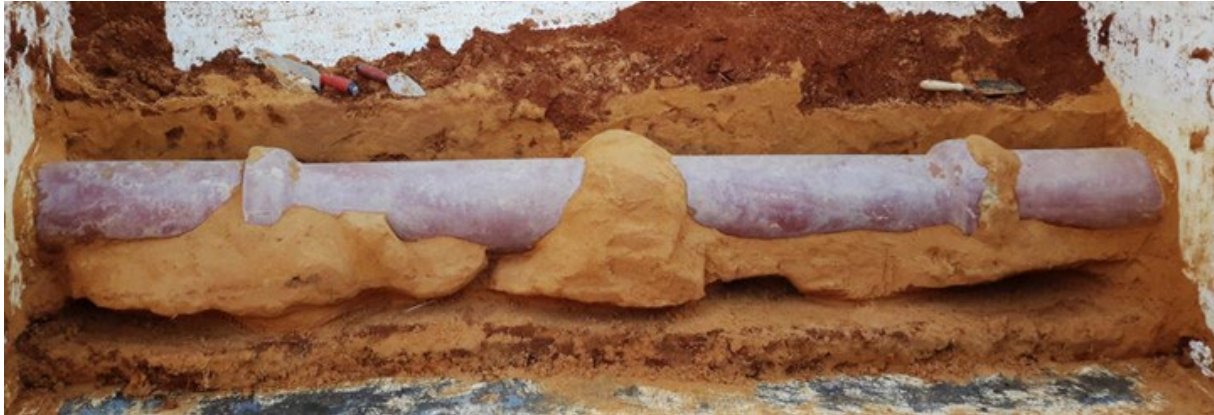
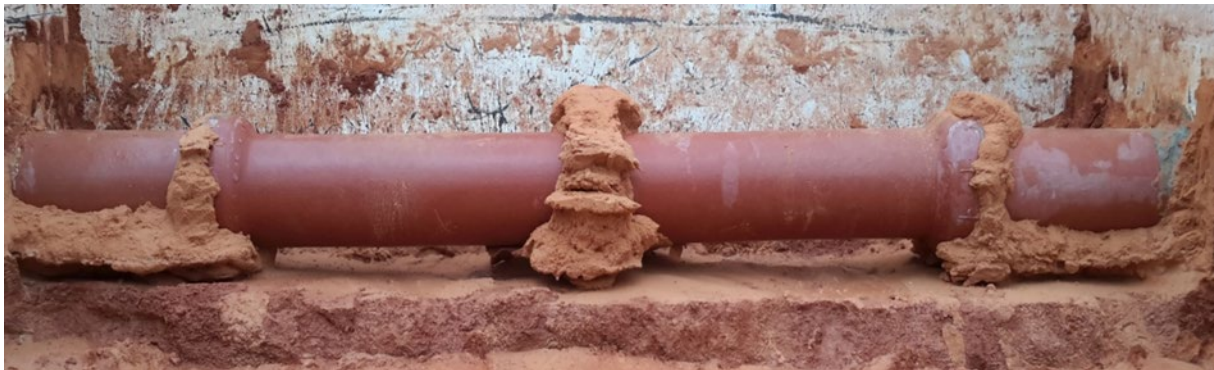
A side-by-side comparison of the results of both tests shows the different formations that were observed between the 23 and 55 second gel time structures. The longer gel time structures were much larger in mass and traveled further underneath the pipe providing better pipe support. Soil saturation of the gelled grout was larger immediately outside of the defect for the longer gel time. The shorter gel time grout formed a small pedestal-like structure immediately under the pipe that was less broad and did not travel as far as the pyramid shape resulting from the longer gel time.

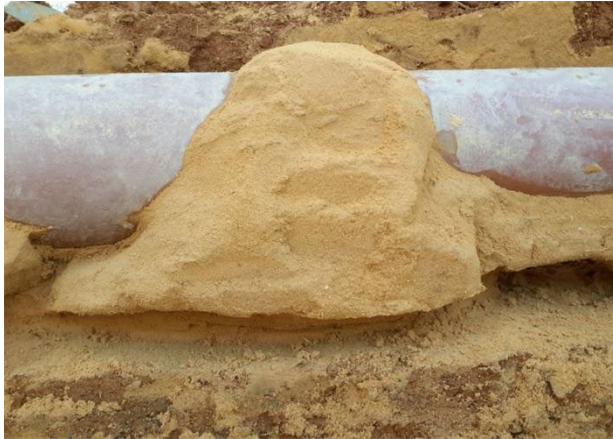
Figure: 127: Defect B 55 Second Gel Time

3. **The shorter gel time resulted in less saturation of the soil and notable fins extending from the grout formation for Defect B.** The formation, while still sealing the defect, provided less pipe support and less gel/soil matrix surrounding the seal, resulting in a less-stable pipe joint.

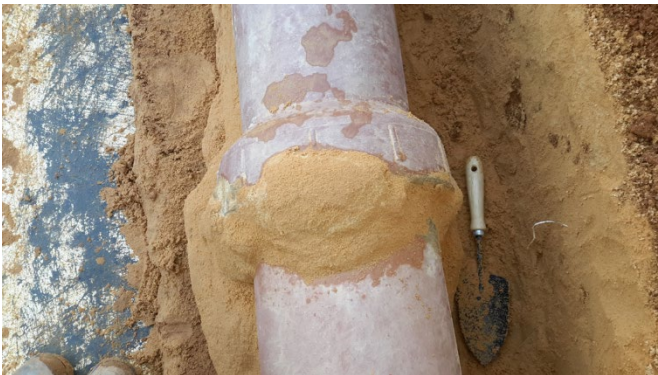
Figure 109: Defect C 55 Second Gel Time

When viewed from above, Defect C (12 o'clock defect) had very similar formations. The amount of the gel/soil matrix was significantly larger on the sides and below the pipe with the longer gel time.

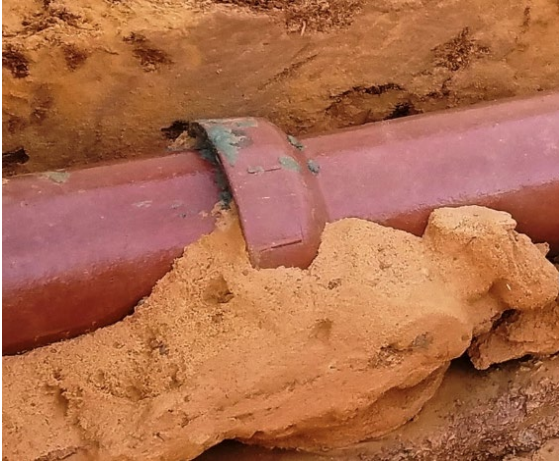
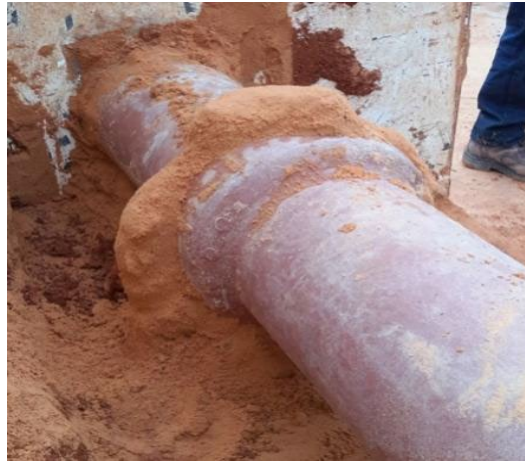
Defect A (3 o'clock position) comparison observations were similar to the Defect C observations. The shorter gel time resulted in a traditional donut shaped structure. With the longer gel time, the grout migrated longitudinally almost connecting to the next grout mass and laterally to the edges of the pipe trench.

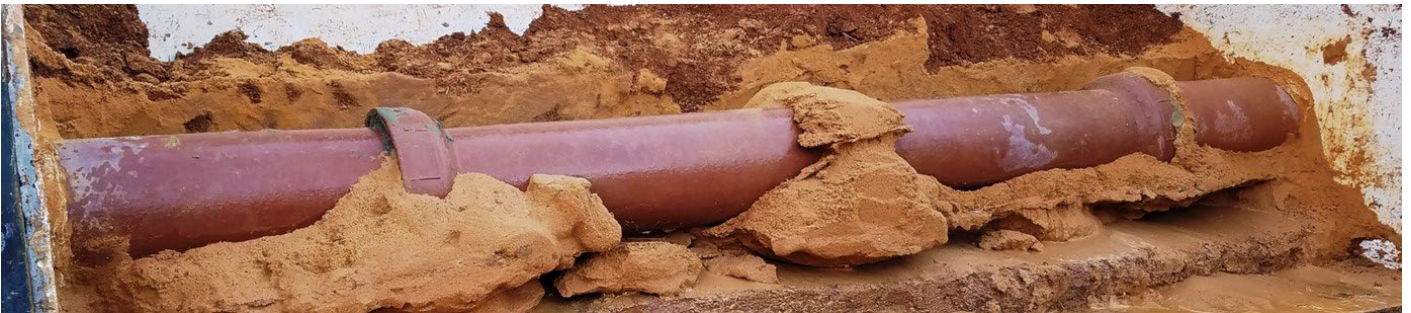
Figure 113: 55 Second Gel Time Grout Formations

This is the full view of the gel/soil matrices using the 23 second and 55 second gel times after washing with a garden hose for full exposure of the differences in grout shapes and pipe support masses.

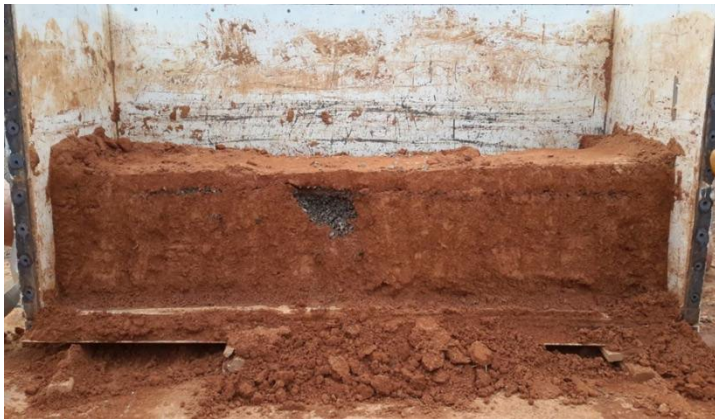
Figure 116: Test Cell After Grouting In 57 Stone

Following the test cell construction procedures described earlier, the trench was constructed of native North Carolina neat red clay. The pipes were then bedded in 57 stone in four-inch lifts and then hand tamped until six inches of stone were placed over the crown of the pipe. Two and a half feet of material was placed on top of the pipe and then plywood plates with sand filled super-sacks were placed on top.

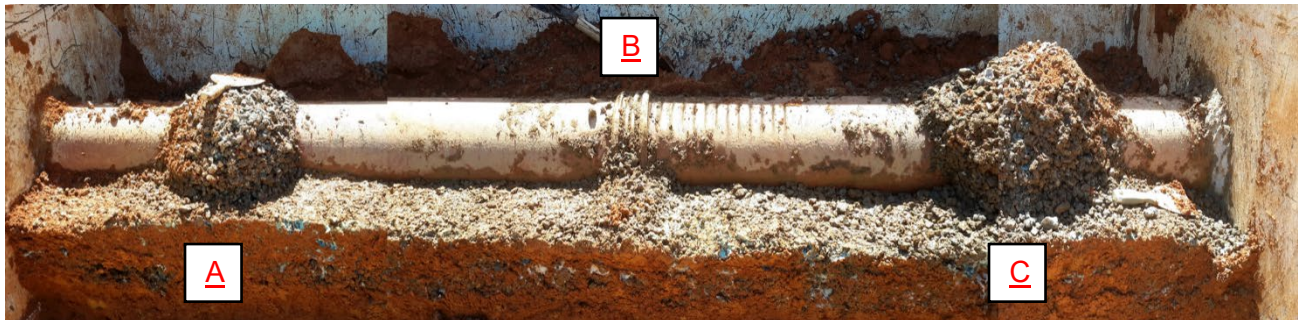
Figure 117: Grout Formation After Sealing in Stone

After the completion of the grout injection and dismantling the test cell, Defect A had a bulb of gel/soil matrix surrounding the Defect at the 3 o'clock position, Defect B only had a gel/soil matrix below the pipe, and Defect C (12 o'clock position) had a bulb of gel/soil matrix surrounding the joint but primarily above the pipe. The area below the pipe within the pipe trench was filled with a gel/soil matrix.

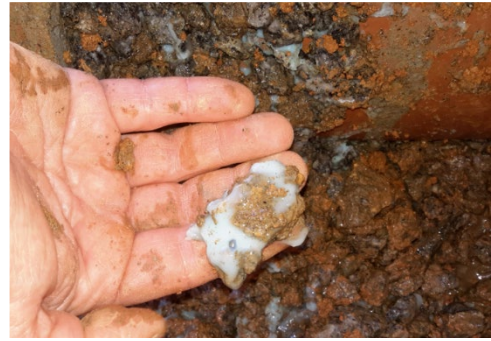
Figure 118: Gel / Stone Matrix

Due to the gradation of the #57 stone, the gel/stone matrix consisted of pockets of gelled grout which filled the void spaces between the stone particles. The combination of

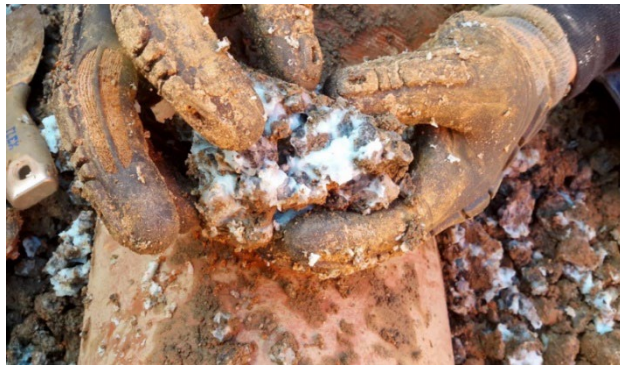
Figure 119: Pockets of Neat Grout

slower gel time, air testing steps, and high air space in the stone, produced a few small air pockets and water in the gel/stone matrix.

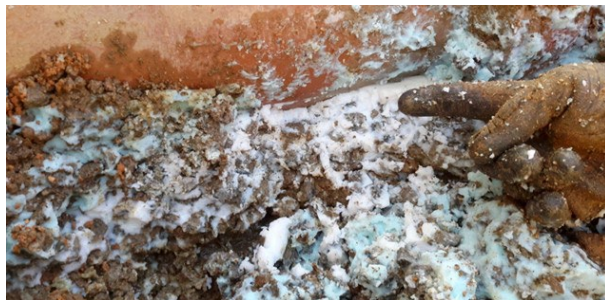
Figure 121: Neat Grout Filling Void Below Pipe

As observed in other tests, the grout quickly permeated the bedding material below the pipe and then proceeded to fill the void in the haunch areas of the pipe with neat grout.
