The Test Cell Grouting Research White Paper

NASSCO

Version: 1.0
May 2023

Introduction: In 2016, a group of engineers, contractors and vendors began working on an update to the NASSCO packer injection grouting technical specifications. It was recognized that recent practices in chemical grouting, called Capital Grouting had achieved significant long-term reductions in infiltration. These results were documented via independently conducted studies. The changes in tools, practices and procedures were based on an understanding of how the grout in situ was achieving long-term seals. These results were backed up by several studies conducted using pre and post rehabilitation control-based procedures to determine that not only was long term infiltration elimination effective but remained effective for over a decade. The group's objective was to update the NASSCO packer injection grouting technical specifications to incorporate the Capital Grouting techniques and to differentiate them from the traditional, short term or pre-rehabilitation grouting methodologies. While developing these specifications several questions arose that necessitated scientific investigations. To confirm/prove the

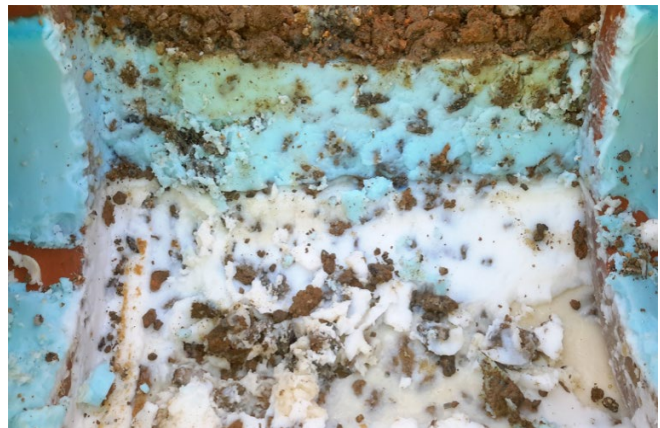
Figure 122: Pipe Removed to Reveal Grout Segment Below

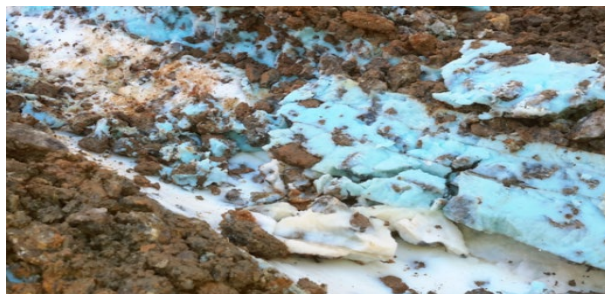
Figure 123: Section of Neat Grout Below Pipe

Because an increased amount of grout was pumped, the grout structures created were very large and extremely stiff. The grout matrix was able to withstand several strikes with a shovel.

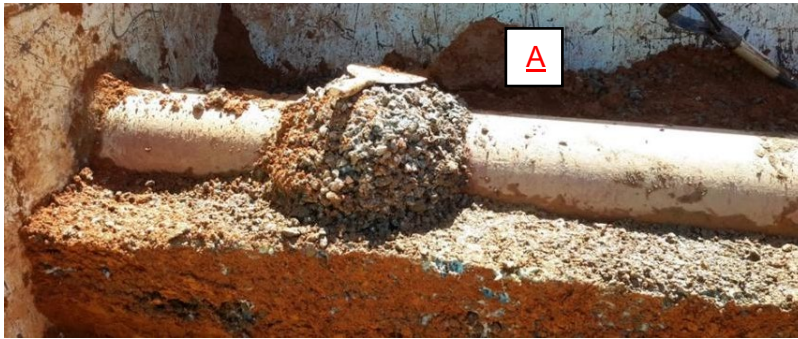
Figure 124: Defect A 23 Second Gel Time in Stone

Due to the low viscosity of the grout, it was able to flow freely through the open voids between the stones. As the grout exited the defect, it filled the voids in between the stones and built upon the base below the pipe. At a gel time of 24 seconds, the uncured grout had enough time to migrate against the sub-base along the length of the pipe improving longitudinal support.

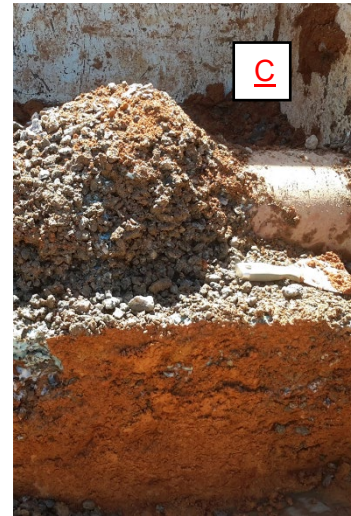
Figure 125: Defect C 23 Second Gel Time

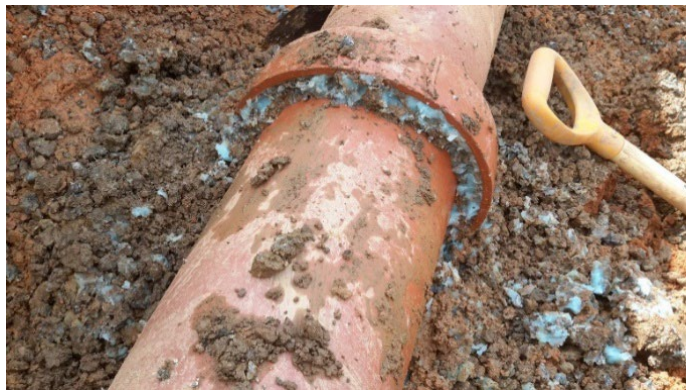
The 14 second gel time in 57 stone yielded some

Figure 127: Grout Filled Circumferential Defect B

honeycombing but was less apparent the closer in proximity to the defect.

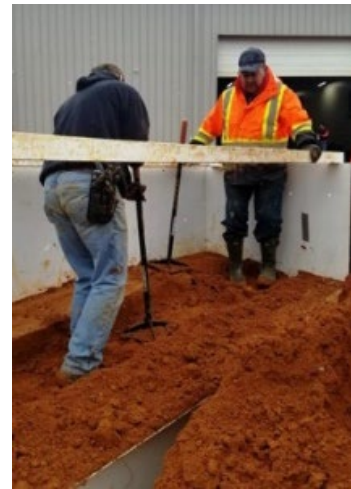
Following the test cell construction procedures described earlier, the trench was constructed of native North Carolina neat red clay. The pipes were then bedded in neat red clay in four-inch lifts and then hand tamped until six inches of material was placed over the crown of the pipe. Two and a half feet of clay material was placed on top of the pipe and then plywood plates with sand filled super-sacks were placed on top. A 55 second gel time was used with a pumping rate of three gallons per minute. The defects were constructed of only oakum. No concrete material was used.

Figure 131: Tamping During Install

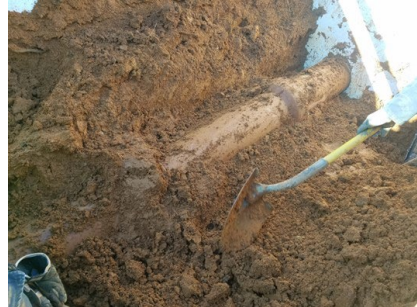
Figure 134: Reveal of Pipe After Grout

After careful exhumation, the grout was found to have fractured the clay by traveling the weakest route and created long fins or filled the fissures within the clay backfill with neat grout. There were no grout rings or masses around the defects. Some fins were up to three feet long and up to 3/8-inches thick. In most cases, the fissures were very thin, but were found to extend far from the point of origin.

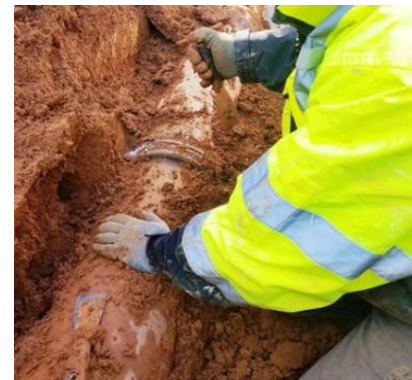
Figure 135: Removal of Clay Backfill

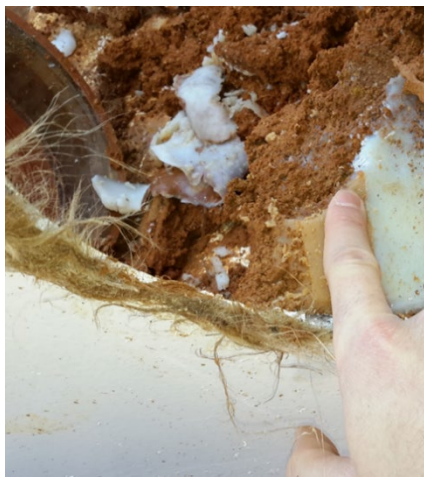
Figure 136: Neat Grout Segments

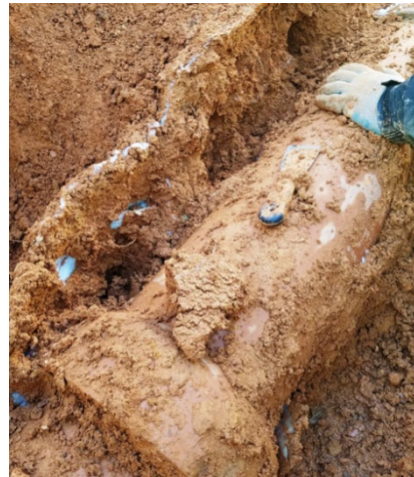
Figure 137: Fins of Grout

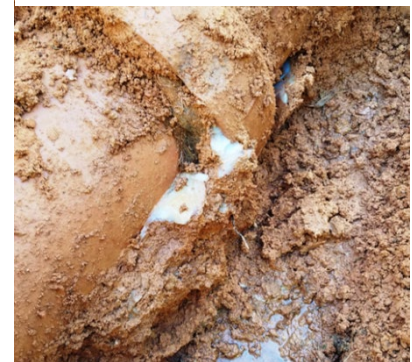
Figure 138: Seal at Defect

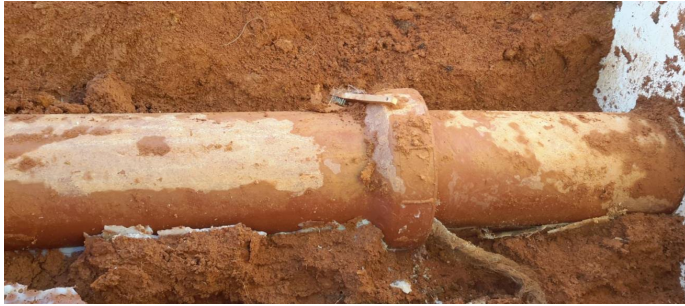
Figure 140: Neat Grout Along Bottom of Pipe

After dissection of the Test Cell, it was observed that there were veins and a thin layer of neat grout that ran along the bottom of the pipe. The veins of grout were observed to be originating from the defects.

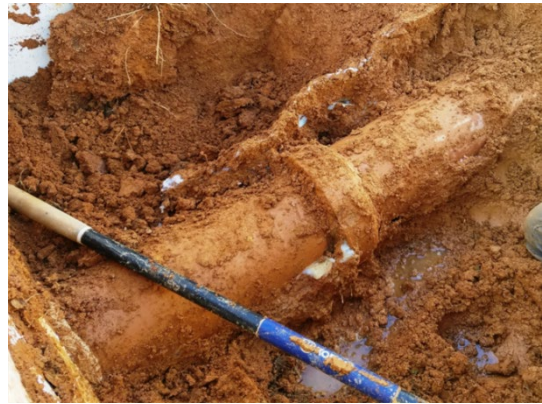
Figure 139: Grout Installed in Clay Backfill

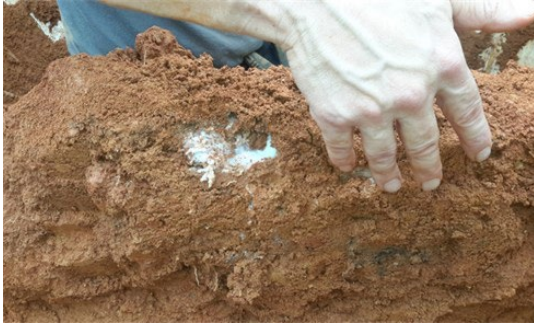
Figure 141: Fin Origin at Defect

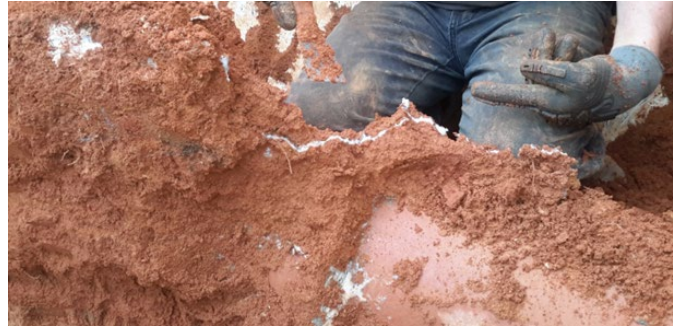
Figure 142: Neat Grout Fin

The fins were constructed of neat grout with very minor mixing with the clay. Following the path of least resistance, the grout traveled in very thin layers outward from the pipe and extended its reach through any fracture within the clay.

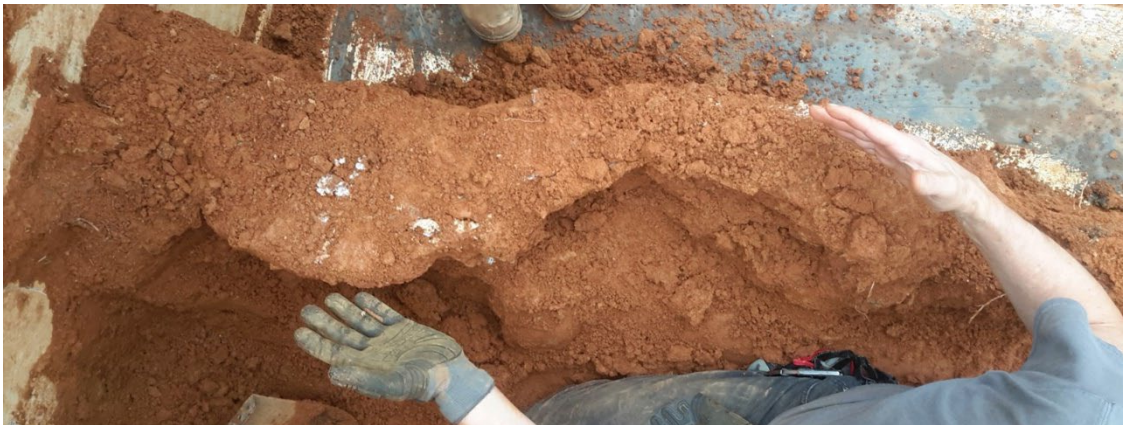
Further dissection of the clay structure proved that the grout only followed the path of least resistance through the fractures. It sometimes traveled upwards with very minimal descent of the grout to areas below the pipe, and little to no gel/clay mixture.

Figure 144: Further Observation of Grout Fins

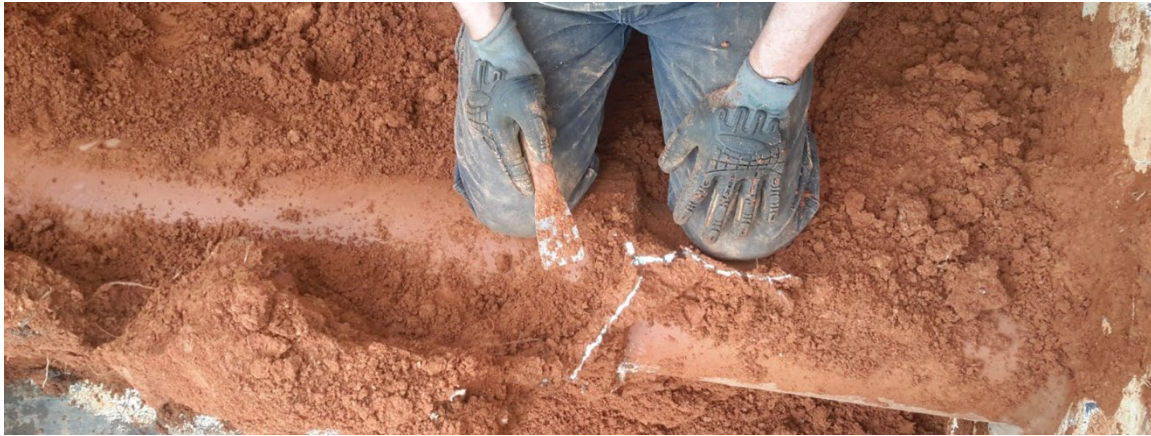
Figure 145: Fin Origin at Defect

Sometimes thick at points, the fins were nearly 100% pure (neat) grout.

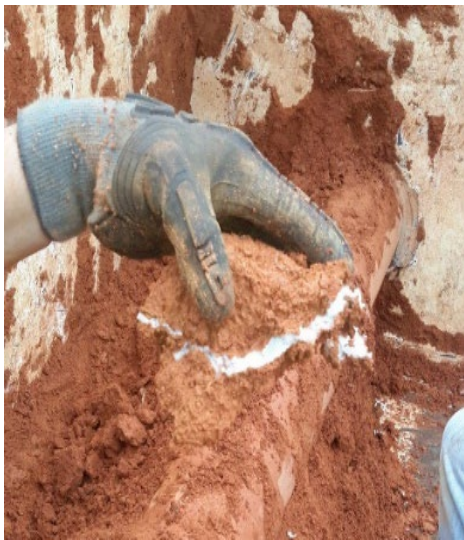
Figure 146: Dissection of Grout Fin

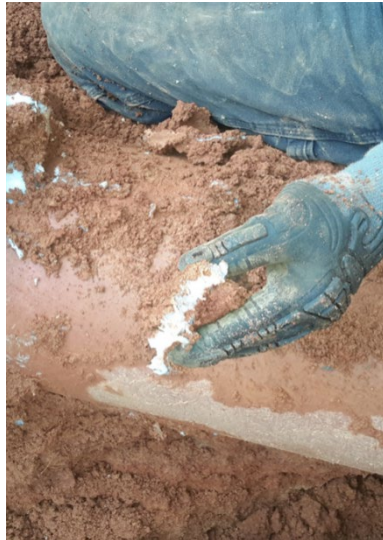
Figure 147: Neat Grout

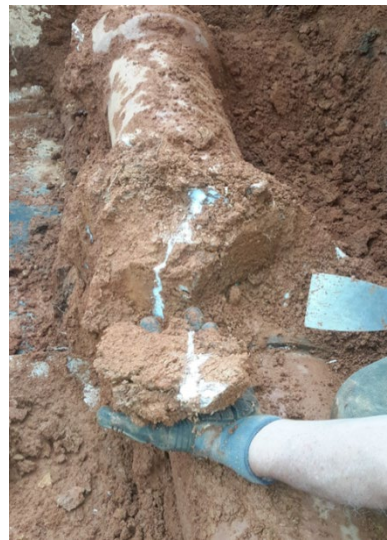
Figure 148: Following Fin to Source

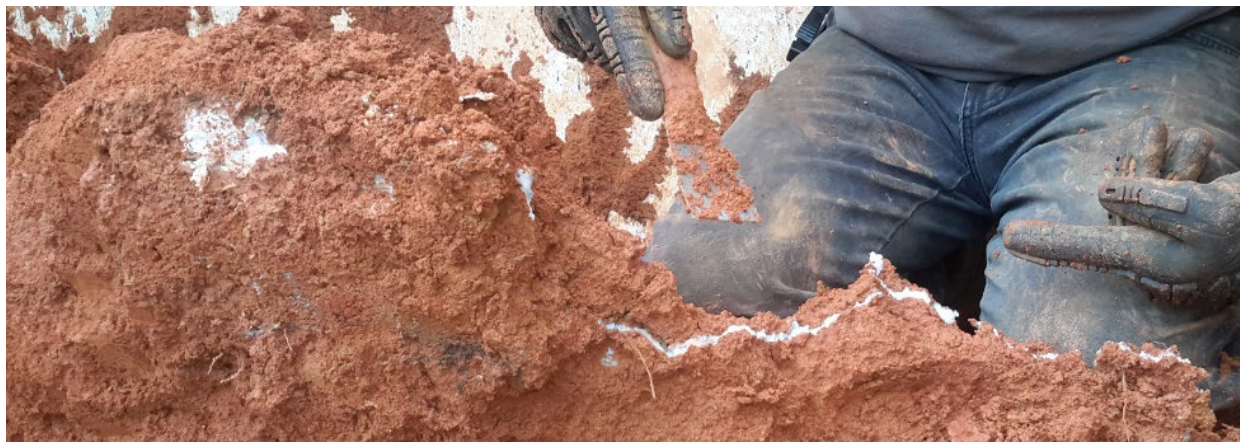
Figure 149: Grout Followed Path of Least Resistance

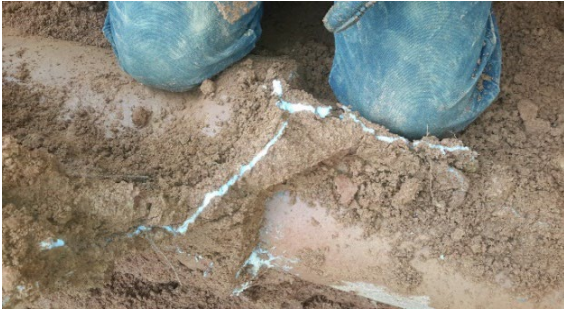
Figure 150: Exposing Defect and Seal

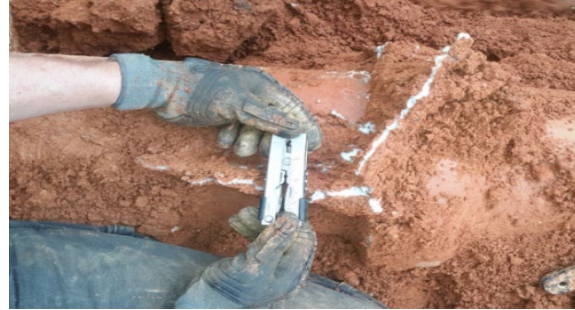
Figure 151: Measurement of Fin Thickness

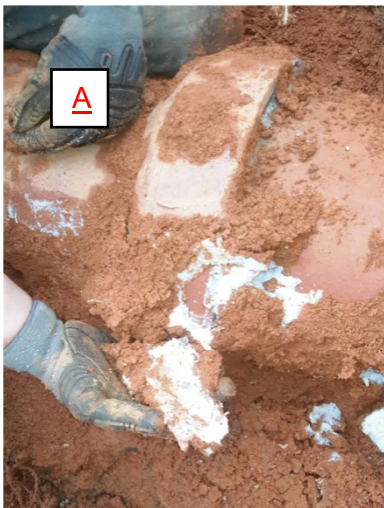
After completion of the dissection of the grout (vein), it was observed that the actual seal at the defect was neat grout.

Figure 152: Defect A Seal

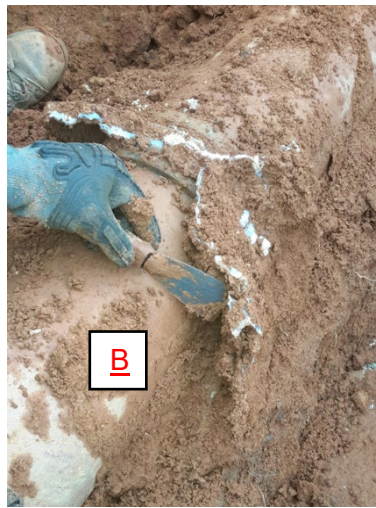
Figure 153: Defect B Seal

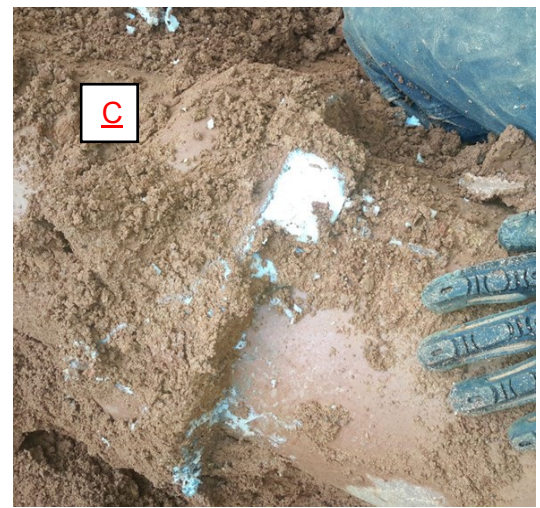
Figure 154: Defect C Seal

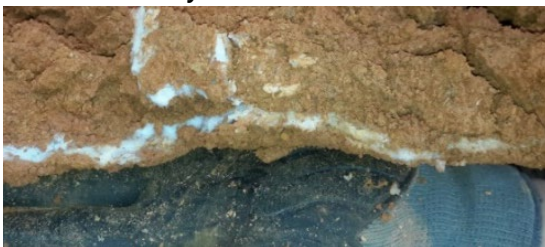
Figure 155: Segment of Grout Fin

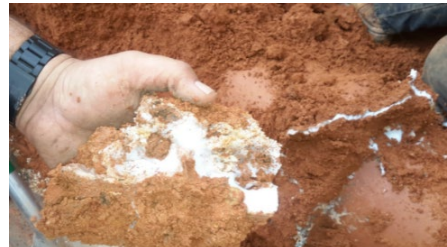
Figure 156: Neat Grout Fin Dissection

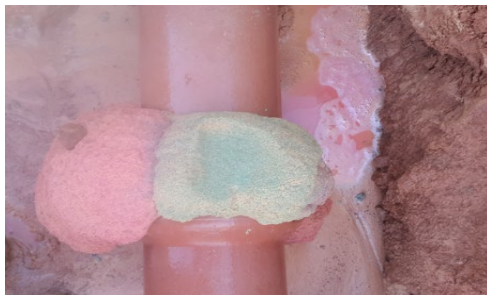
2. **If the first grout pumped is allowed to set, a second injection of grout cascades around the hardened formation.**

Figure 158: Red and Blue Grout Separated

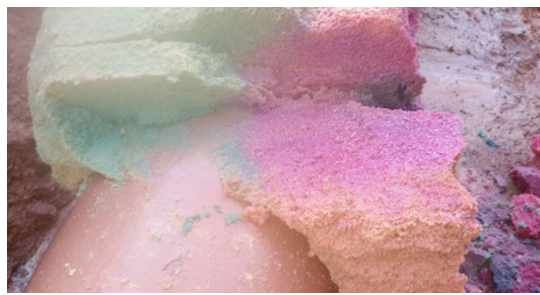
Depending upon the objective of the injection, if stage grouting methods are employed, pumping intervals and gel time must be considered (i.e., bedding support vs. seal only).

Figure 159: Grout Stages

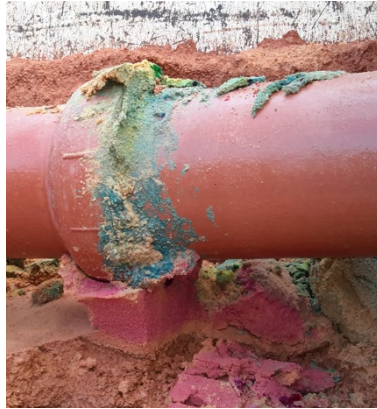
The gel/soil matrix was observed to rest on the bedding, then traveled longitudinally and laterally along the pipe and trench.

Figure 161: Colored Grout Layers

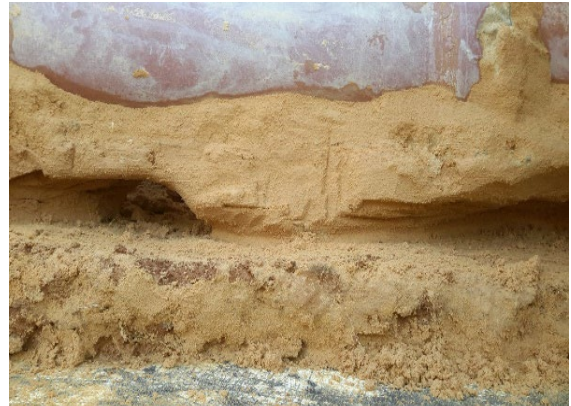
Figure 162: Gel / Soil Matrix at Base of Trench

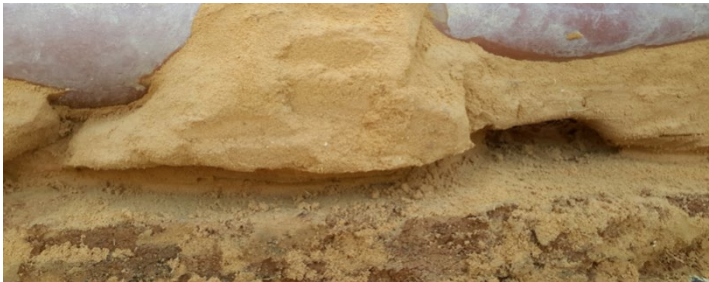
2. **The extent and spread of the pipe support created by the gel/soil matrix was a direct function of gel time (i.e., how long the acrylamide stayed liquid before it began to solidify).**

Figure 163: 55 Second Gel Time Pipe Support

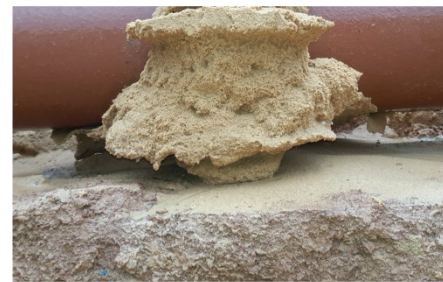
Figure 164: 23 Second Pipe Support Matrix

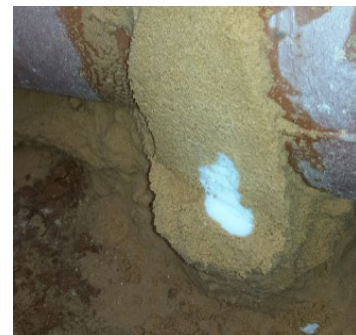
During the 25 second gel times (in sand), the void areas below the pipe were filled with neat grout and the defect was sealed but the pipe was not significantly stabilized as compared to the 55 second gel time.

Figure 165: Neat Grout Seal

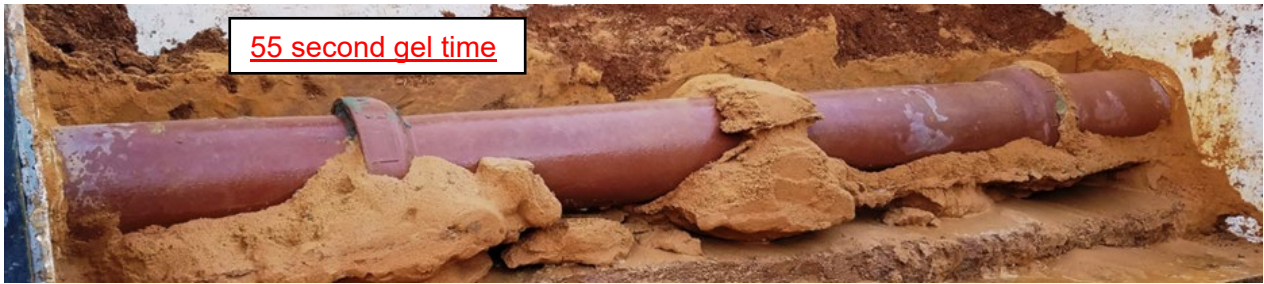
Visually, the gel/soil matrices at 23 and 55 seconds look notably different in terms of creating pipe support. The 55 second gel time structures were larger in mass and traveled further underneath the pipe. Soil saturation of the gelled grout was larger immediately outside of the defect. The 23 second gel time grout formed a structure immediately

Figure 166: 55 Second Gel Time

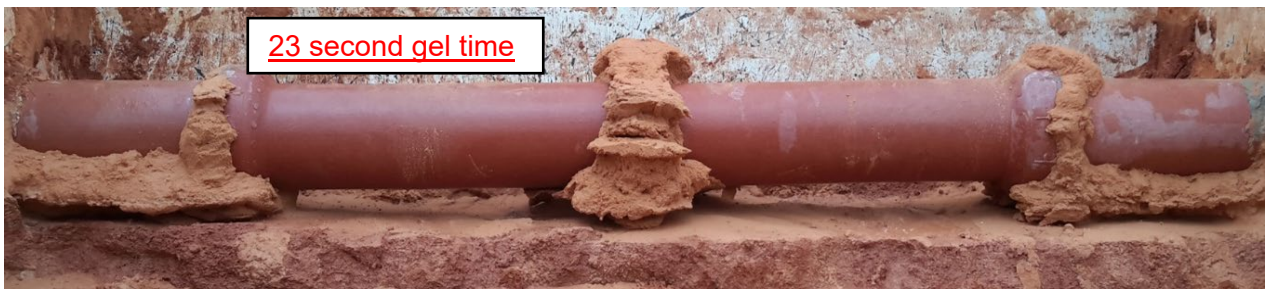
Figure 167: 23 Second Gel Time

underneath the pipe that was less broad and did not travel as far. A shorter gel time also limited the build-up of grout within the trench which is crucial to the prevention of water migration.

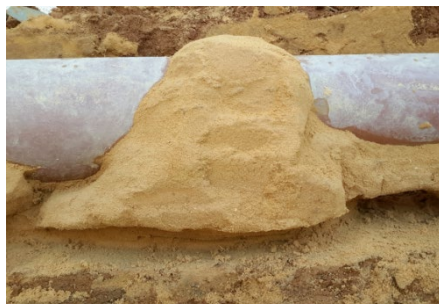
6. Shorter gel times result in less saturation of the surrounding bedding and created fins of grout as opposed to creating a solid mass encapsulating the pipe. Longer gel times yielded a larger gel-soil matrix adjacent to the defect, and improving embedment stabilization, pipe support, and added protection to the seal of neat grout.

Figure 168: 55 Second Gel Time

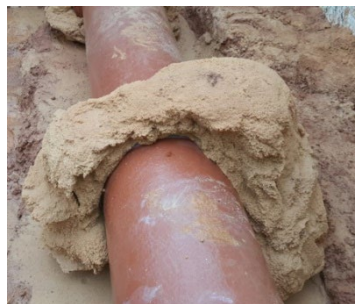
Figure 169: 23 Second Gel Time

7. Shorter gel times tend to fract upward through the gelled masses and create larger formations above the pipe.
8. ***While it is possible to seal a joint with a short gel time and minimal grout injected, the most effective, long-term seal is achieved using a longer gel time that allows additional grout to be installed under and around the pipe.***

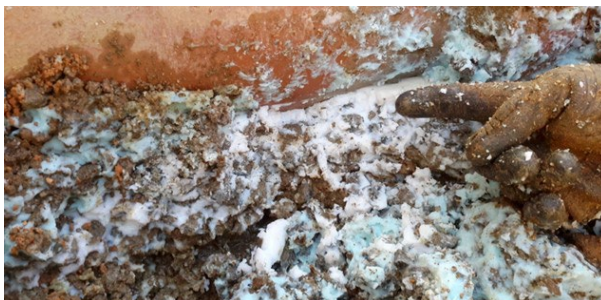
As observed in other tests, the grout quickly permeated the bedding material below the pipe and then proceeded to fill the void in the haunch areas of the pipe with neat grout.

Figure 170: Gel / Stone Matrix

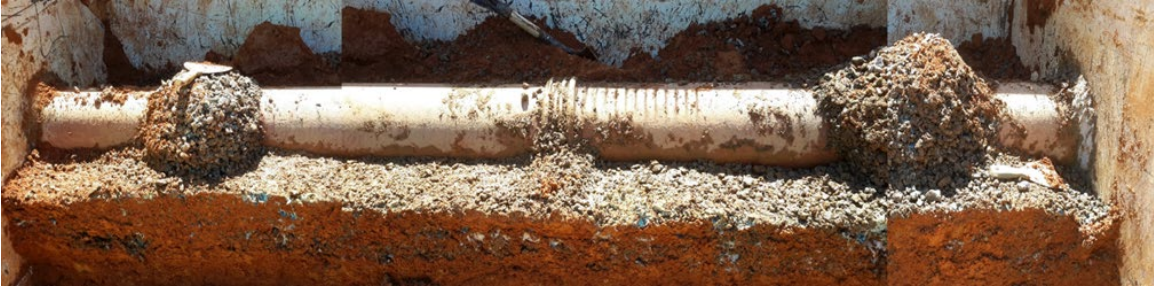
Due to the void space between the stone, a large amount of grout would be required to achieve a proper cradle. A seal can be achieved in clean stone using a short gel time as low as 10-15 seconds. The goal is to achieve the proper amount of grout placement around the defect to prevent infiltration. In some cases, the optimum gel time may be as low as 10-15 seconds to reach a complete seal in stone. The trade-off is there is very little grout provided for pipe stabilization and trench damming.

Figure 172: 24 Second Gel Time Grout / Stone Matrix

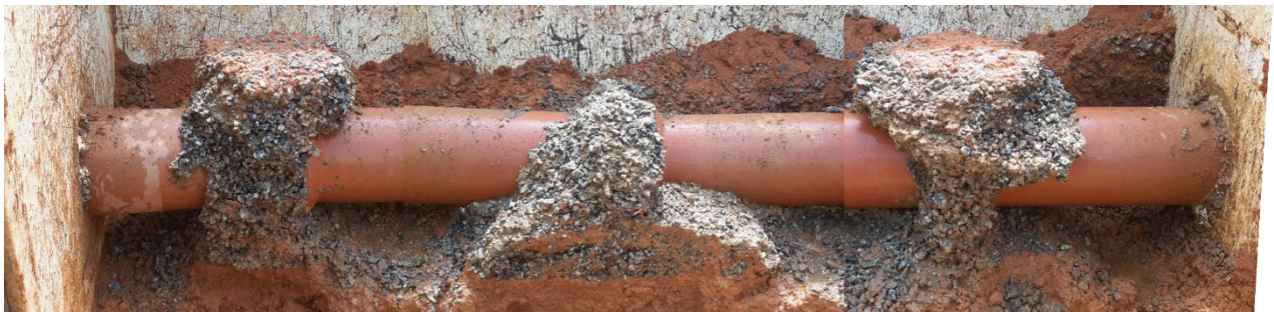
4. Using a gel time of 14 seconds as compared to 24 seconds and stage grouting allowed for a cradle to be built, avoided honeycombing, and permitted a seal of neat grout immediately outside the defect.

Figure 173: 14 Second Gel Time Grout / Stone Matrix

This is very similar to other test results with quicker gel times as the grout immediately descends below the pipe, creating a pedestal. During the second injection, the grout builds upon that thinner base and migrates upward instead of down and around the pipe.

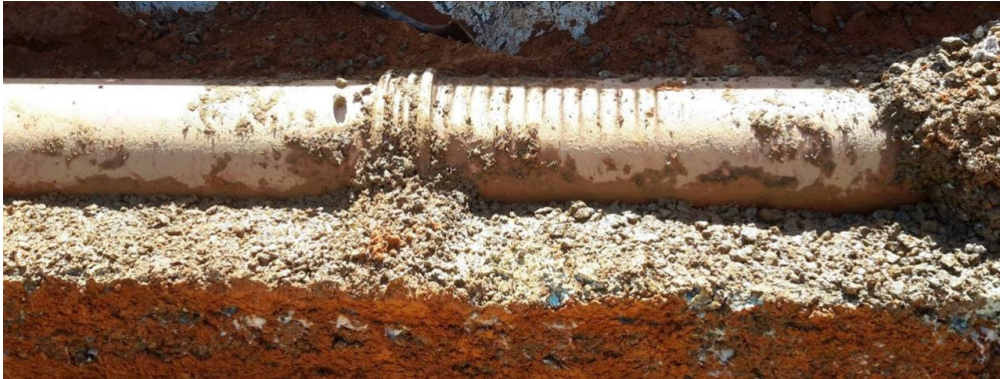
Figure 174: Defect A at 3 O'clock Position Grouting in Stone

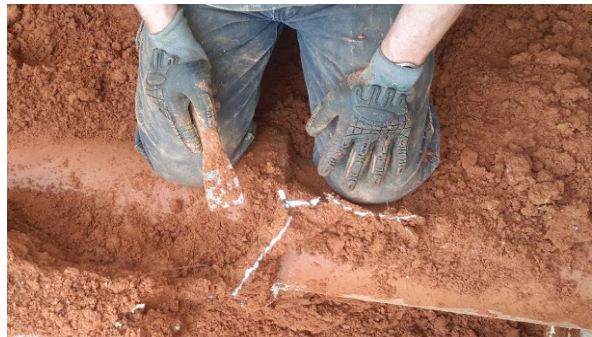
1. ***Pipes that are supported in clay bedding are not good candidates for Capital Grouting because these materials allow for a very minimal mixture of soil and grout.***
2. ***When sealing pipes embedded in clay, short gel times should be used to limit grout movement through fissures, voids, and gaps.***
3. ***The structure of the clay bedding does not allow for the creation of a ring of grout surrounding the pipe.***
4. ***Cradling of the pipe does not occur as the grout only follows the fissures within the clay bedding structure.***

Figure 175: Grout Fin Extending from Defect

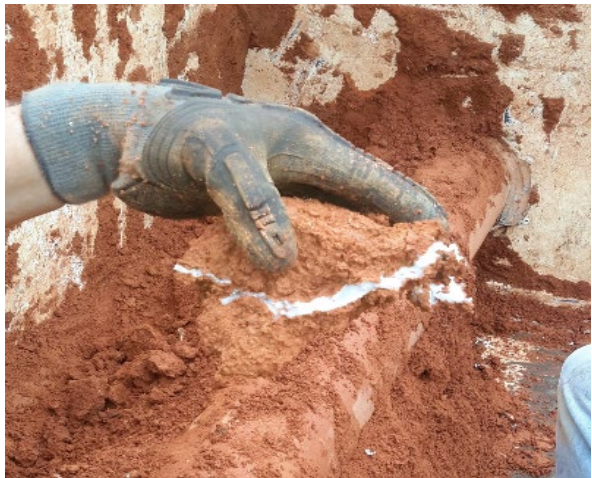
Figure 176: Neat Grout Fin

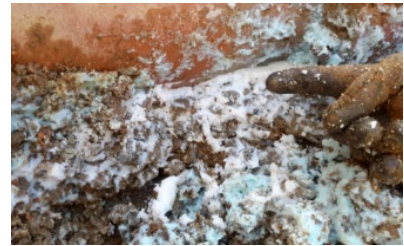
After bedding settlement, there is almost always a void located directly underneath the pipe. As grout exits the pipe defect, it descends below the pipe and fills that void with pure grout. This is attributable to the rules of gravity and the path of least resistance, or through the least amount of confining pressure, if it remains liquid.

Figure 179: Stone Grout Trial

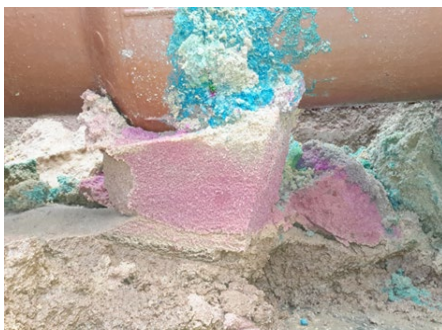
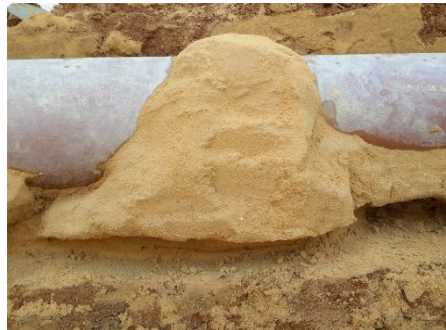
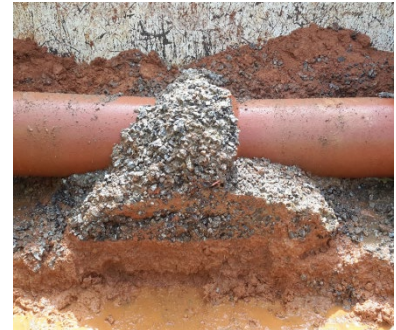
2. After filling the immediate voids, grout drops to the bottom of the pipe trench while still liquid.

The gel time needs to be long enough for the liquid grout to descend through the bedding material and contact the undisturbed trench subbase. The longer the gel time, the wider the base along the pipe profile, and more stabilization is achieved. In no instance did the grout penetrate the tightly compacted native subbase of the Test Cell.

Figure 180: Colored Grout Trial

Figure 181: Sand Trial

Figure 182: Stone Trial

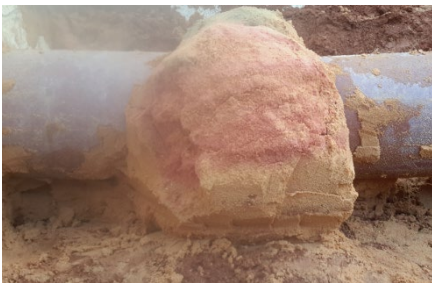
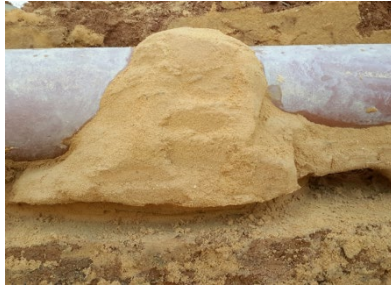
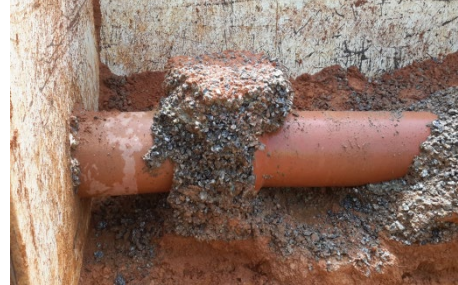
3. After reaching the pipe trench bottom, grout will cascade around the solidified grout base and create a wide pyramid that is confined to the walls of the pipe trench.

Grout migration creates a pyramid structure underneath the pipe and increases the cradling and pipe stabilization effect. The grout builds up from the base until it reaches the pipe breach or defect, creating the final seal.

Figure 183: Colored Grout Trial

Figure 184: Sand Trial

Figure 185: Stone Trial

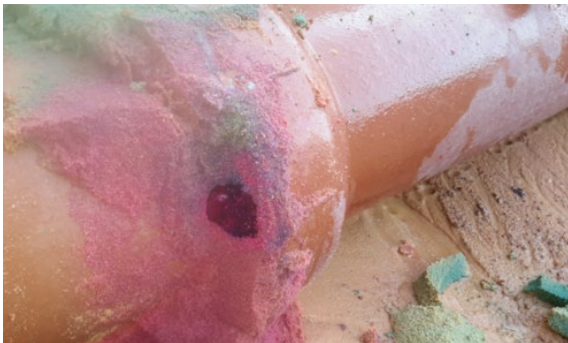
- 4. In all cases, the defect itself was sealed with neat grout inside the confines of the defect and the final plug is neat grout.**

Figure 186: Defect A Grout Seal (3 O'clock)

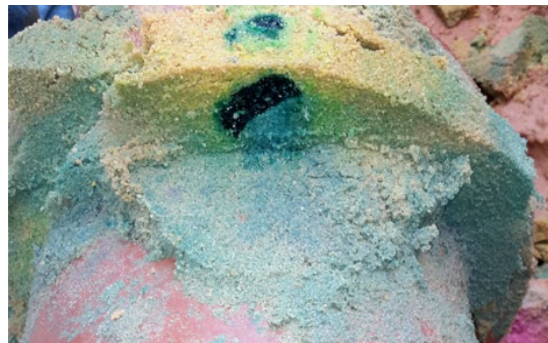
Figure 187: Defect C Grout Seal (12 O'clock)

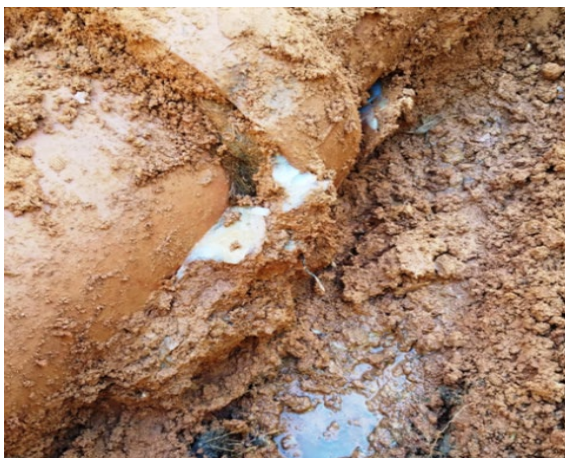
Figure 188: Neat Grout Seal at Defect

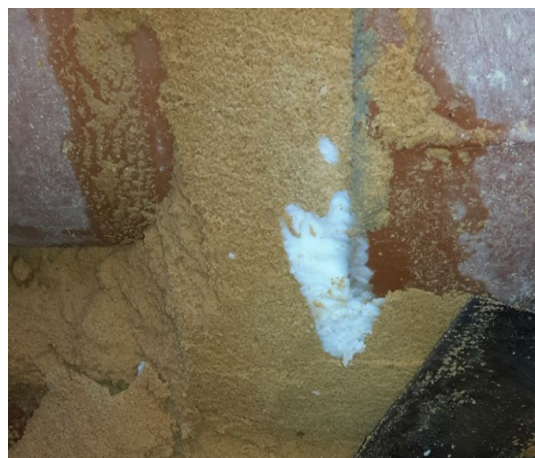
Figure 189: Neat Grout Located at Defect

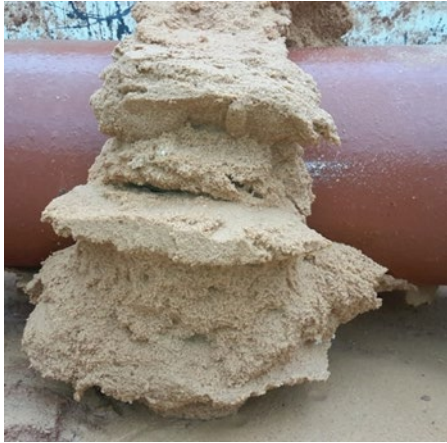
3. Shorter gel times result in grout fin formations at the breakthrough sites.

Less grout used at faster gel time means less soil saturation and more gel in fins.

Figure 190: 23 Second Gel Time

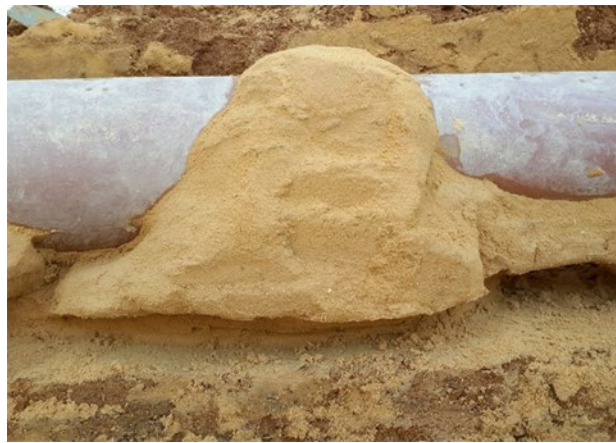
Figure 191: 55 Second Gel Time

4. Longer gel times allow for larger grout masses outside the pipe walls and defects.

In pipe bedding materials, the liquid grout will saturate the soils, creating a larger gel/soil matrix outside of the neat grout that is immediately present outside of the defect. The larger mass promotes longevity of the newly installed exterior pipe seal.

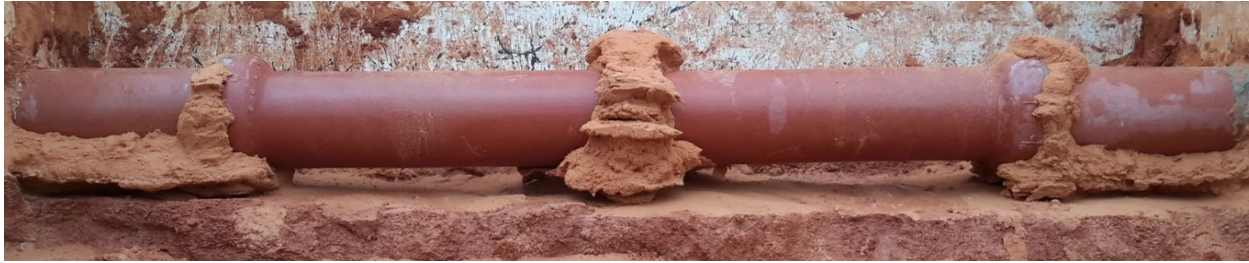
Figure 192: 23 Second Gel Time Grout Formations

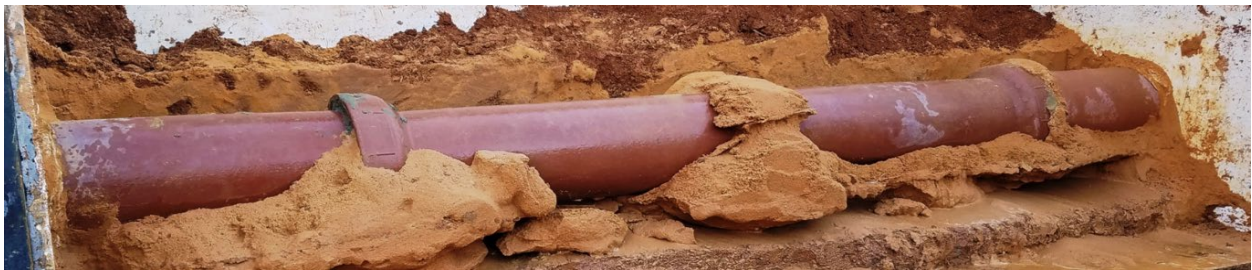
Figure 193: 55 Second Gel Time Grout Formations
