# Reaching Out

An innovative mix of technologies helps a Massachusetts sewer department seal leaking laterals, reduce I&I, and preserve treatment plant capacity

Seal 34 laterals 20 feet from the mainline

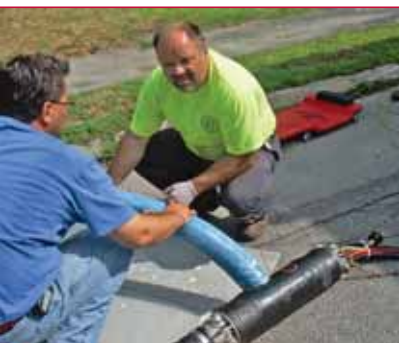
Grout truck operator Gary Millington (in fluorescent safety shirt) helps Marc Ancil of Logiball lubricate the inflated bladder with silicone. After lubrication, vacuum will retract the bladder into the hose carrier.

The lateral packer from Logiball has a 25-foot-long rubber hose, or carrier train, attached to the bladder launcher with pan-and-tilt camera. After the bladder is lubricated with

silicone, vacuum retracts it though an opening at the head of the carrier train. "Whenever something that long is put in a sewer, anything can go wrong," says Falconieri. A remote-controlled winch at the downstream manhole advanced the packer.

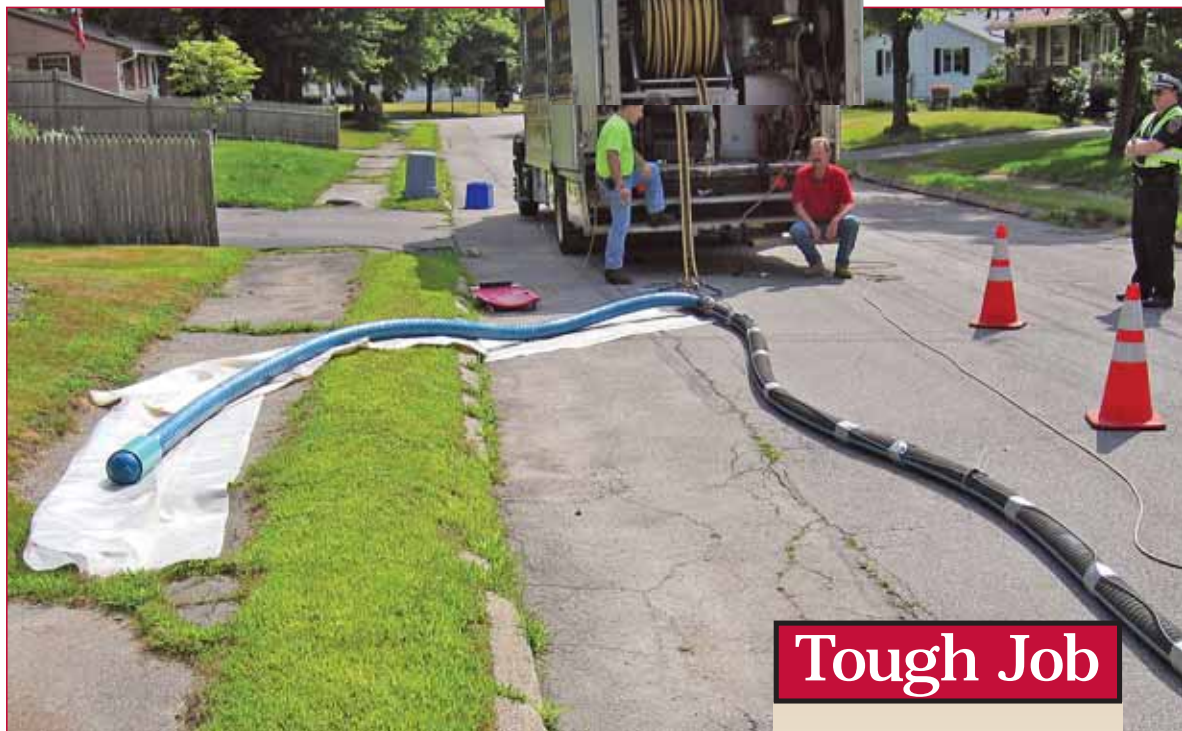
The inflated blue bladder is lubricated and ready for retraction by vacuum back into the hose carrier.

Retracting the bladder was difficult because of its length and the friction created by residual grout in the pipe. "It's not a solid skin coating, but a thin gelatinous mass," says Falconieri. "Had we ruined the bladder, our profits would have gone with it." Millington's steady hand avoided damage.

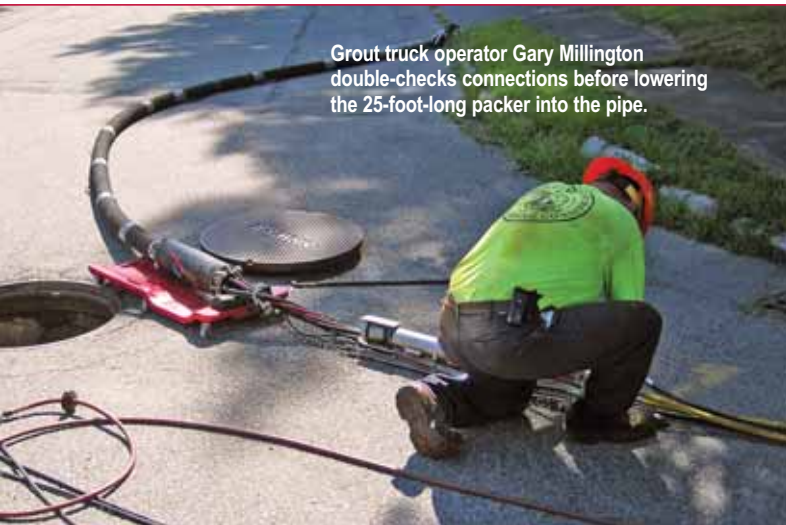
Grout truck operator Gary Millington double-checks connections before lowering the 25-foot-long packer into the pipe.

der up the lateral. A maximum pressure of 40 psi seals the ends of the packer against the walls. "To achieve an effective seal of 20 feet, the packer travels 25 feet due to the plug at the end," says Falconieri.
