EAST COAST TOWN'S PERMANENT SOLUTION TO A COSTLY PROBLEM

BY RAY BAHR, P.E.

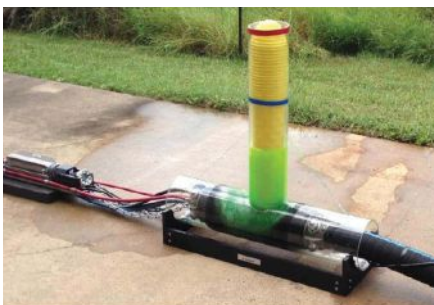
Waterford's Utility Department regularly inspects the collection system for defects/issues and to comply with CMOM regulations. Upon inspecting the pipelines, several major leaks at the intersection where lateral pipes were connected

to the mainline sewer were observed. After identifying 14 laterals were leaking substantially, it was determined that most of the laterals had infiltration of at least 4 gallons per minute, equating to 29,433,600 gallons per year (or roughly \$136,000 per year in treatment cost for the excess water added to their system).

Looking for a permanent solution to this costly problem, Waterford's Utility Department turned to sewer grouting.

The sealing of laterals and the lateral connections to the sewer main to eliminate groundwater infiltration is achieved through the process of sewer grouting. Mainline sewer grouting has been around for over 60 years and lateral grouting has been around for nearly 30 years. Both are an effective tool for stopping groundwater infiltration into manholes, joints, and lateral connections.

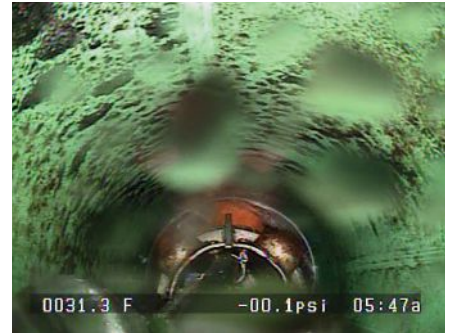
The Waterford project was completed by Green Mountain Pipeline Services in September 2021 and took only three days to seal the 14 laterals. The town of Waterford cleaned and televised the sewer lines prior to the grouting operation commencing. This also helped to lower the overall cost by performing the work in-house. Eighty-four gallons of acrylamide grout were used to completely stop the infiltration, eliminating not just the excess water, but also the needless spending for the additional water to be treated at the plant.

Why is injection grouting so effective at stopping infiltration? The answer simply lies in the materials and techniques utilized. The process of grouting consists of injecting two water-based component chemicals through an open joint or defect. When the two liquids meet, a chain reaction occurs, resulting in an inert gel that is installed on the outside of the pipe. This "gel" time is controllable and is set based upon the amount of material placement required for the diameter of the pipe, the length of the lateral bladder, and the pumping rate. As the liquid grout exits the open joint or defect it immediately drops below the pipe. This helps to reestablish pipe stabilization by creating a cradle underneath, while filling any voided areas around the pipe. The grout then forms a seal around the defect and combines with the surrounding backfill, creating a gel/soil matrix that reinforces the seal. During grouting operations, operators closely monitor the pressure and the amount of grout pumped. This helps to assure that the proper amount of grout is placed.
