NASSCO REPORT: GROUTING COMMITTEE

CONTRACTOR, MUNICIPALITY, MANUFACTURER Work Together Solve A Unique Problem In Norwich, Connecticut

BY JOHN P. MANIJAK

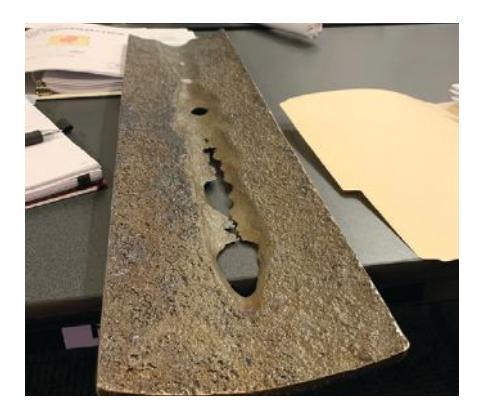
ity officials in Norwich, Connecticut, discovered an unusual problem involving 2,695 ft of 14-in. force main pipe in September 2019. The gritty materials, pumped on a regular basis, had worn away the bottom of the 45-year-old cast iron pipe. Over time, the pipe walls were breached by the materials, allowing an inflow of heavy amounts of ground water when the system was not pressurized, affecting its overall capacity.
