FOCUS: SEWER

DRIVING DOWN I/I

CIPP lining and grouting of lateral connections proves to be a sound formula for tightening sewers in Graettinger, Iowa

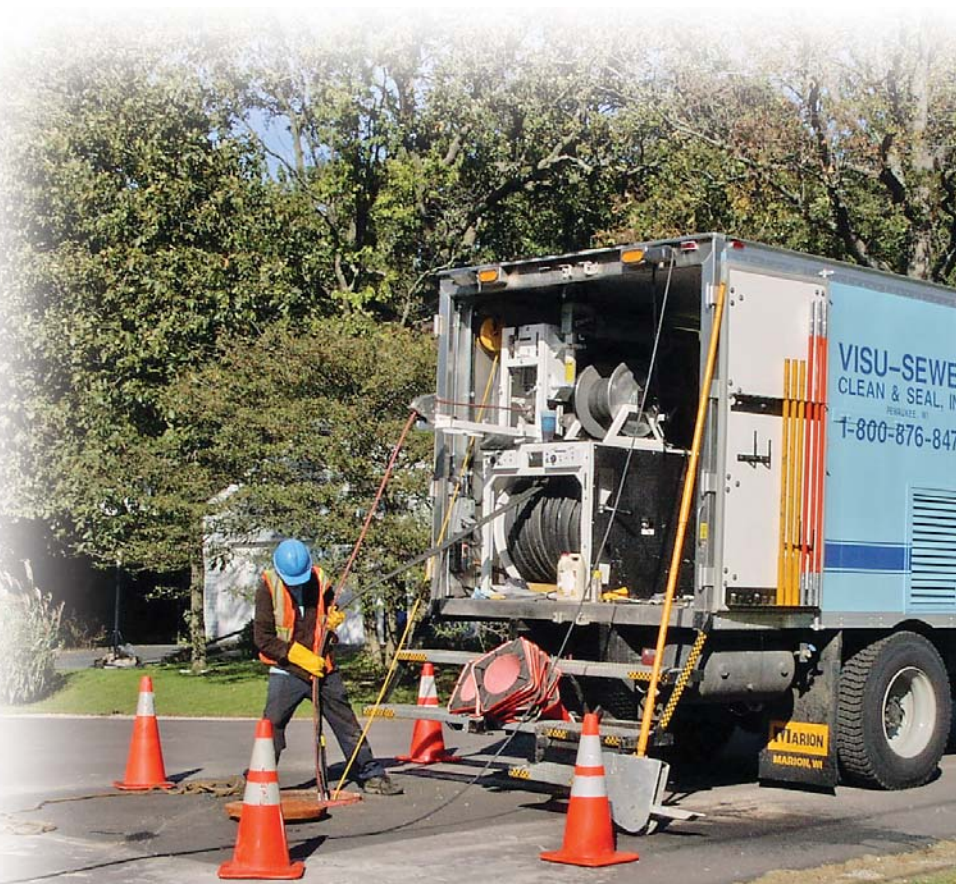
A technician from Visu-Sewer Clean & Seal Inc. starts an inspection of a sewer main in the City of Graettinger, Iowa, as part of the city's program to control inflow and infiltration.

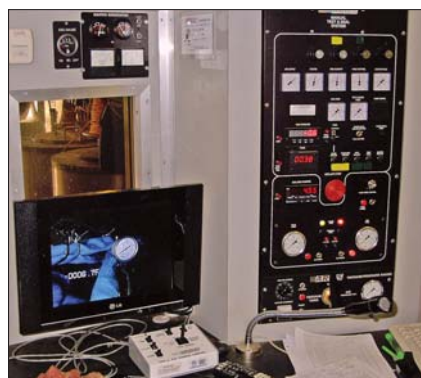
A fully outfitted camera van lets operators control the inspection and record findings.

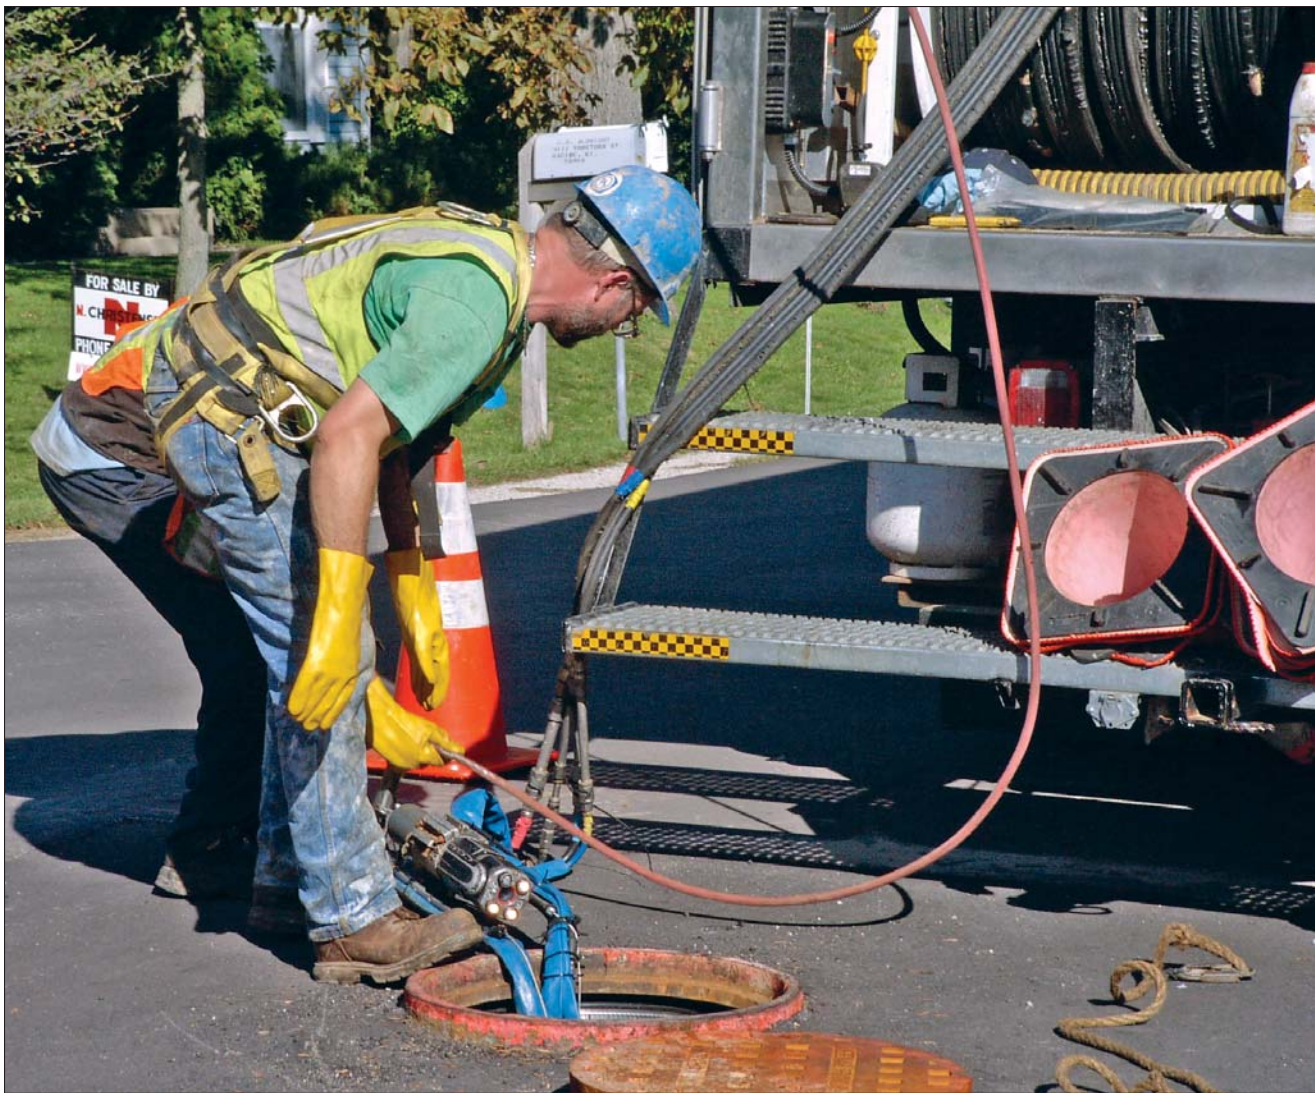
Camera inspection precedes CIPP lining in the city's I/I control program.

Visu-Sewer video-inspected the lines, cut roots, and cleaned the pipe with high-pressure waterjetters. The crew worked from manhole to manhole, inserting the liner through the pipe section using water inversion.

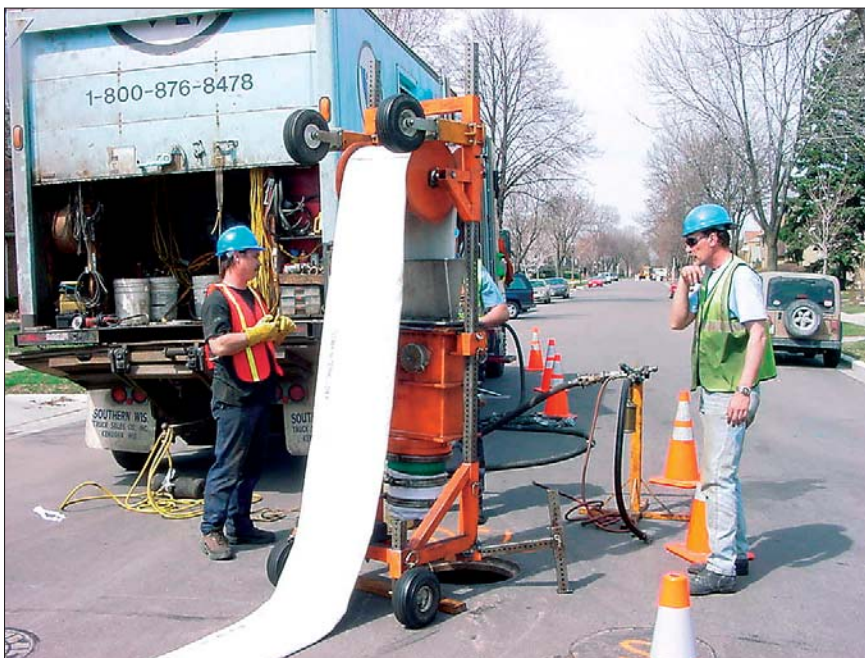
A crew prepares a CIPP lining from National Liner for a trenchless repair job on a main in Graettinger.

The custom-designed liner was made of 6 mm and 7.5 mm needle-woven polyester felt. The first step is a wet-out process in which the liner is laid on a processing table and a resin and catalyst system injected. The liner is then fed through rollers that compress the “dry bag” to a specified thickness and saturate it with resin.

To prepare the liner for the pipe, the first five to six feet are opened to a circular shape, and the leading edge is fastened to a circular frame. This results in a pocket into which water is pumped. The force of the water propels the liner down the pipe and turns it inside out.

Once deployed, the ends of the liner are secured, and the water is heated to 180 degrees F to activate curing. Temperature and water pressure are maintained throughout the process. Once cured, the liner is cooled and the ends trimmed and secured inside the manhole.

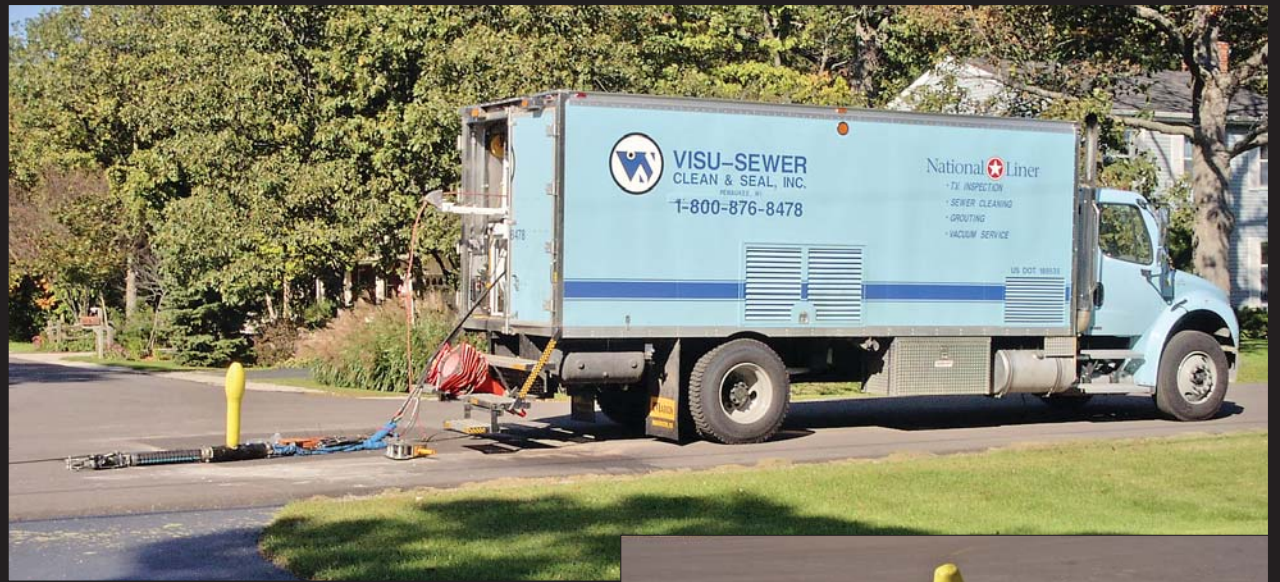
A lateral packer system from Logiball Inc. is deployed on a grouting project. Grouting and CIPP lining were the city's preferred methods of sealing lines against I/I.

In the last step to prevent infiltration, connections to the main line were grouted in place. During this process, three bladders within the lateral packer from Logiball Inc. were used to isolate the connection: two in the mainline (one on each side of the connection) and a third in the lateral. The bladders were inflated and the joint pressurized
