TECH TIPS

FROM NASSCO

SEWER POINT REPAIRS

By NASSCO member Mark Metcalfe, Vice President Operations, Hoffman Southwest Corporation

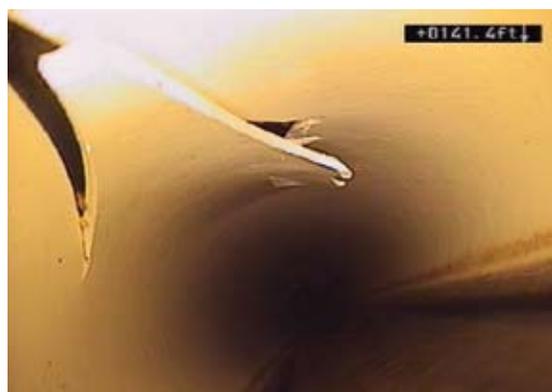
SEWER LINE BEFORE CIPP POINT REPAIR

Damaged sewer lines are a big problem across the United States. Hundreds of miles of sewer lines are rehabilitated every year. In addition to the miles of sewer pipes needing repair, there are millions of spot or point repairs that need attention as well. Damages such as longitudinal cracks, missing pieces of damaged pipe, offset joints, root intrusion or leaking joints are conditions that often need to be repaired.

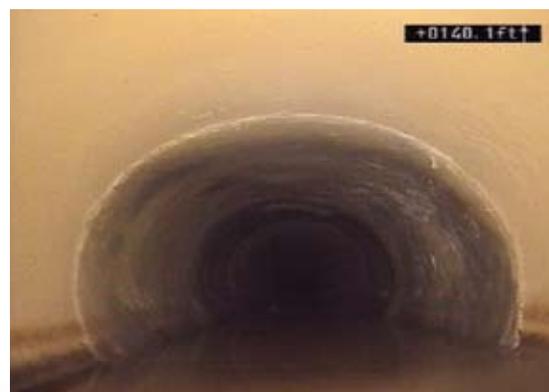
SEWER LINE AFTER CIPP POINT REPAIR

In the sewer line point repair process, using the CIPP method, the lining material is generally composed of a felt and/or fiberglass tube or mat that is saturated with epoxy, silica or UV resin. The saturated material is then placed on an inflatable bladder or carrier that is placed in the pipe through the manhole access. It is positioned over the damaged pipe, while the carrier is inflated to press the saturated material against the pipe, holding the material in place until the resin is cured.

The repair will generally have a smooth, tapered finish at the ends, between the repair and the host pipe. The entire process can be observed with a CCTV camera to insure proper application. CIPP repairs can usually be done in lengths of 6" to 20'+ and in pipe diameters from 4" to 24".
